**AVIATION SAFETY INVESTIGATION REPORT  
200402747**

**Boeing Co  
B737**

**24 July 2004**

## **Final ATSB report into the 24 July 2004 Boeing 737 ground proximity caution near Canberra**

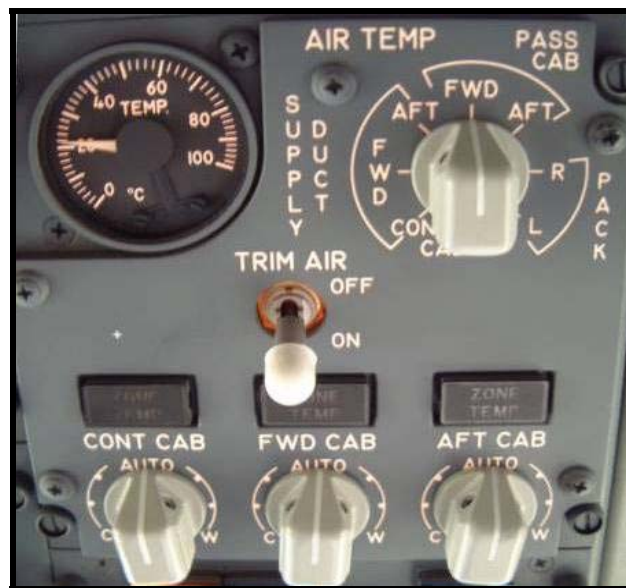
**Figure 1: Boeing 737-800 series aircraft air conditioning control panel showing the three zone temperature selectors and supply duct temperature gauge.<sup>21</sup>**

The 737 crew experienced difficulty maintaining the temperature on the flight deck at an acceptable level. The air conditioning system continued to supply excessively warm air to the flight deck zone even though the crew had adjusted the CONT CAB zone temperature selector to schedule a cooler temperature.

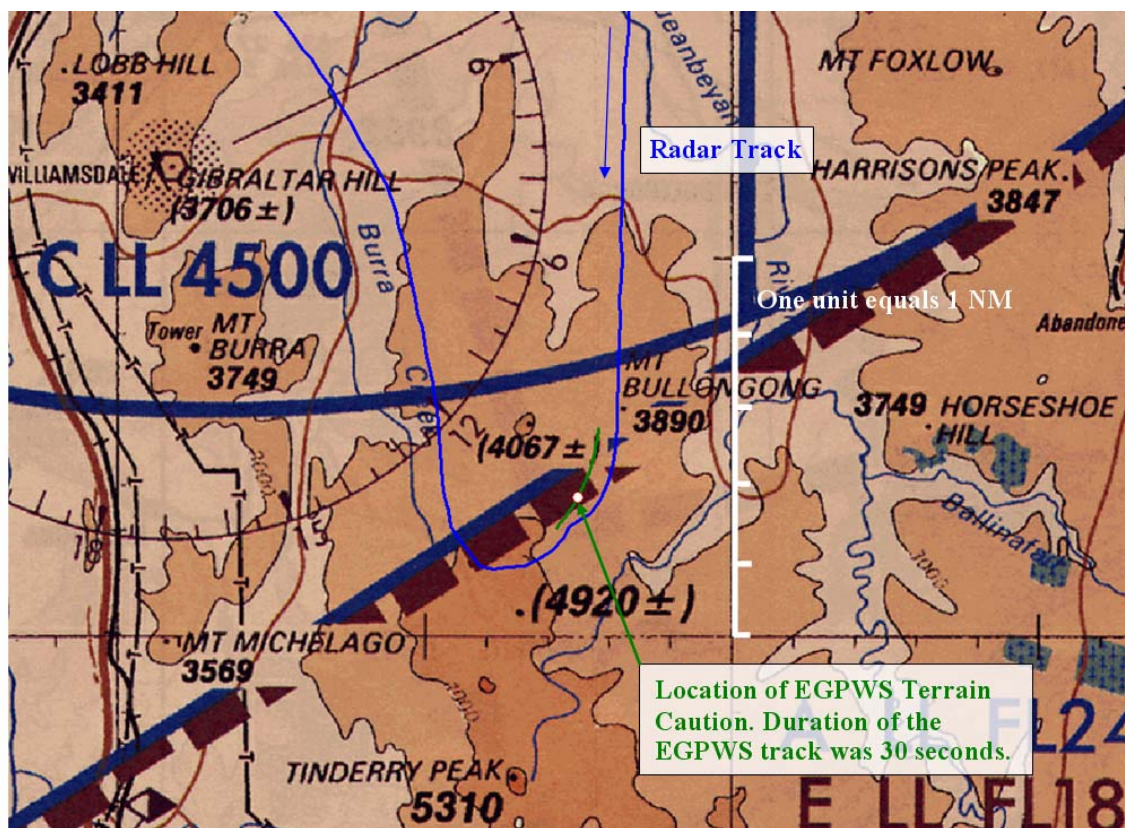
**Figure 3: Position of aircraft at the time of terrain caution, shown on visual terminal chart dated 27 November 2003.**

At the time of the 'CAUTION TERRAIN' message the aircraft was 2,502 ft above terrain. During the turn, it passed 0.6 NM (1.11 km) north abeam and 810 ft higher than the closest terrain that had a spot height of 4,920 ft above mean sea level. It also passed 2.7 NM (5 km) north abeam Tinderry Peak. The aircraft climbed to 6,500 ft and subsequently joined the runway 35 localiser.

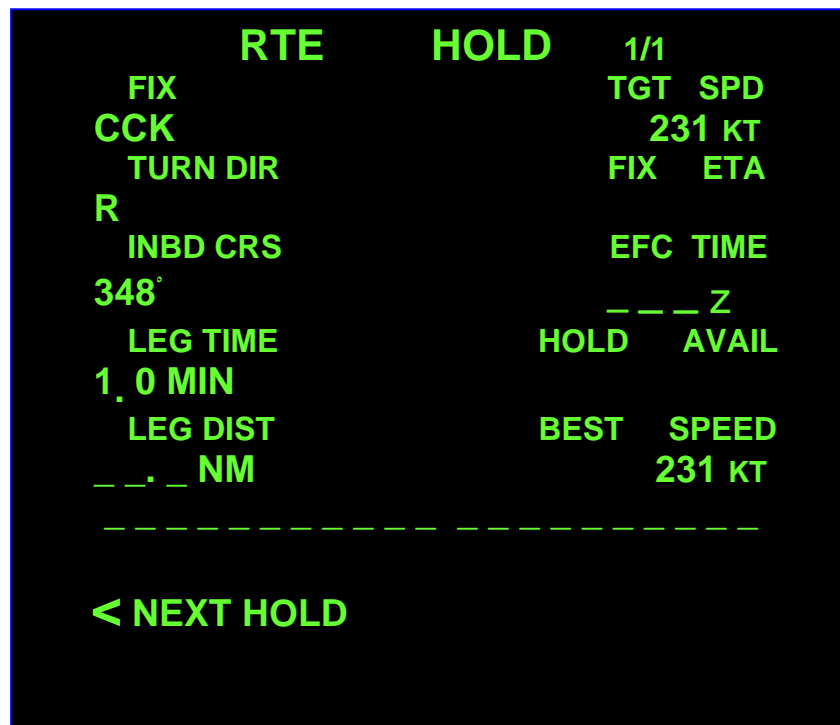
**Figure 5: FMC CDU display showing hold page before leg distance had been entered.**

In order to enter the holding pattern, the copilot selected the Route Hold (RTE HOLD) page on the CDU and entered the holding fix of CCK. The FMC HOLD page provided fields that prompted the copilot to input or modify the inbound course (INBD/CRS); leg time (LEG TIME), and leg distance (LEG DIST), as well as speed and target altitude (SPD/TGT ALT).

The FMC has no facility to enter a holding pattern DME limit (as is necessary when holding at CCK at 5,000 ft). The DME limit is based on the Canberra DME, which is located at Canberra airport. The CCK locator is positioned approximately 10.9 NM from the Canberra DME.

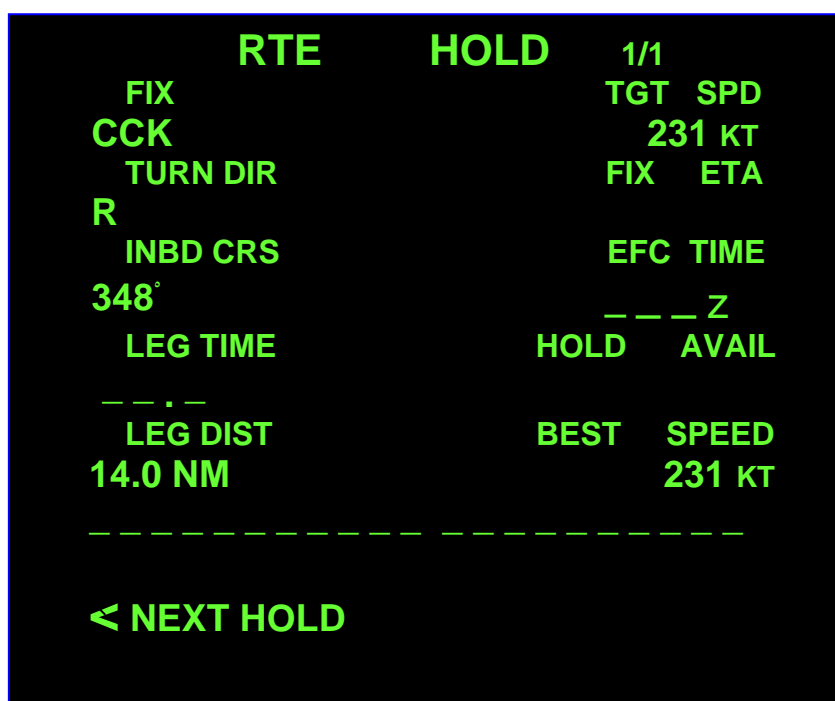
**Figure 6: FMC CDU display showing hold page after leg distance had been entered.**

Entry of a LEG DIST on the FMC CDU HOLD page causes the previous displayed LEG TIME to be deleted.

The effect on the 737 crew of inadequate preparation, rushed procedures and inadequate verification of entered data resulted in the aircraft flying a holding pattern with a leg length of 14 NM, taking the aircraft outside the designed protected area of the CCK holding pattern.

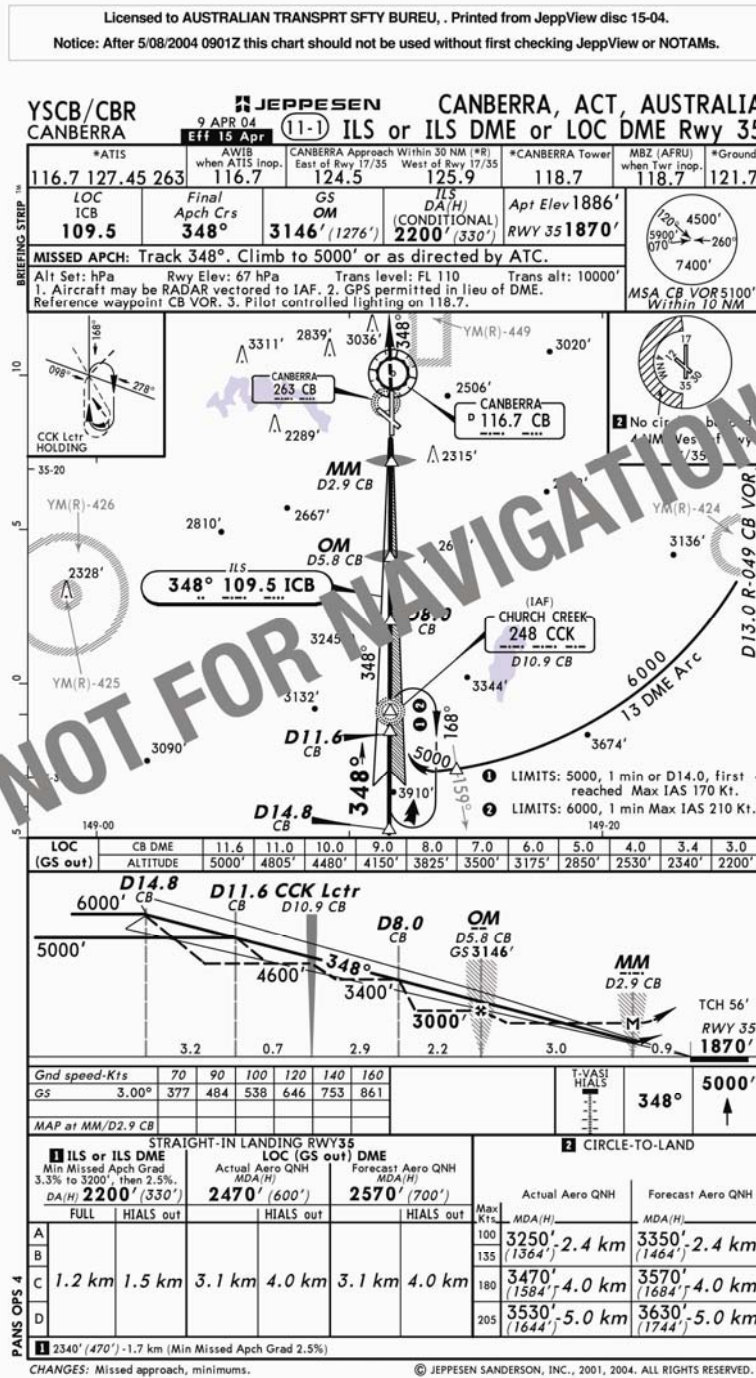
Figure 7: Canberra runway 35 ILS approach chart valid at the time of the occurrence.

The purpose of an instrument approach chart is to display the data necessary for the safe execution of the appropriate procedure. The Canberra runway 35 ILS approach chart depicted in figure 7, which was used by the 737 crew, included information denoting limits for aircraft holding at CCK. Although the DME limit associated with the CCK holding position utilised the Canberra DME, this was not detailed on the holding pattern limits on the chart. There was no DME located at CCK. The 737 crew involved in this occurrence were prompted by the FMC to enter a LEG DIST for the holding pattern at CCK, however, the chart did not provide the crew with that specific information.

The aircraft operator has amended its procedures to require a higher altitude for aircraft holding to the south of Canberra and the chart publisher is amending charts to reduce the likelihood of misinterpretation.
