**REPORT
ON
ACCIDENT TO AIR INDIA EXPRESS BOEING 737-800
AIRCRAFT VT-AXV ON 22nd MAY 2010
AT MANGALORE**

**AIR MARSHAL BN GOKHALE, PVSM, AVSM, VM (Retd)
FORMER VICE CHIEF OF AIR STAFF, INDIAN AIR FORCE**

**GOVERNMENT OF INDIA
MINISTRY OF CIVIL AVIATION**

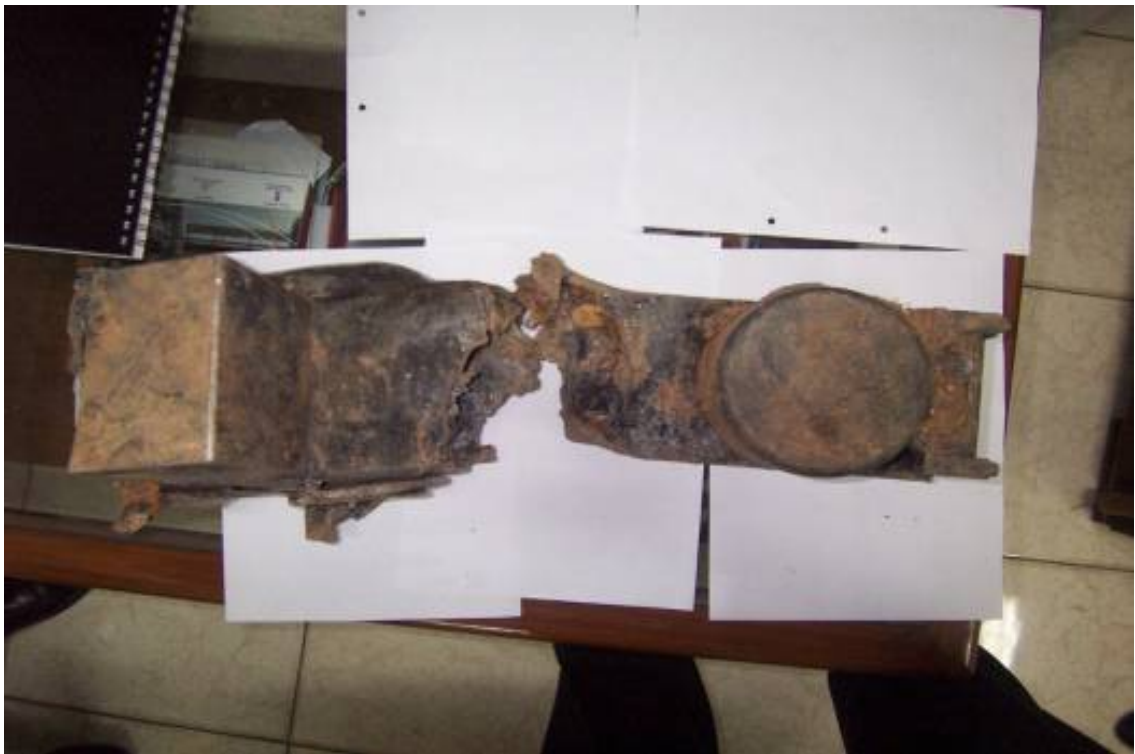
The DFDR of accident aircraft was recovered from the crash site after 3 days i.e. on 25th May 2010. The DFDR had sustained substantial damage due to impact and post impact fire. The DFDR had broken into two pieces, one piece contained the Crash Survivable Memory Unit (CSMU) and other containing the connector as shown in the photograph below:-

Photo 4: Digital Flight Data Recorder (In Damaged Condition)

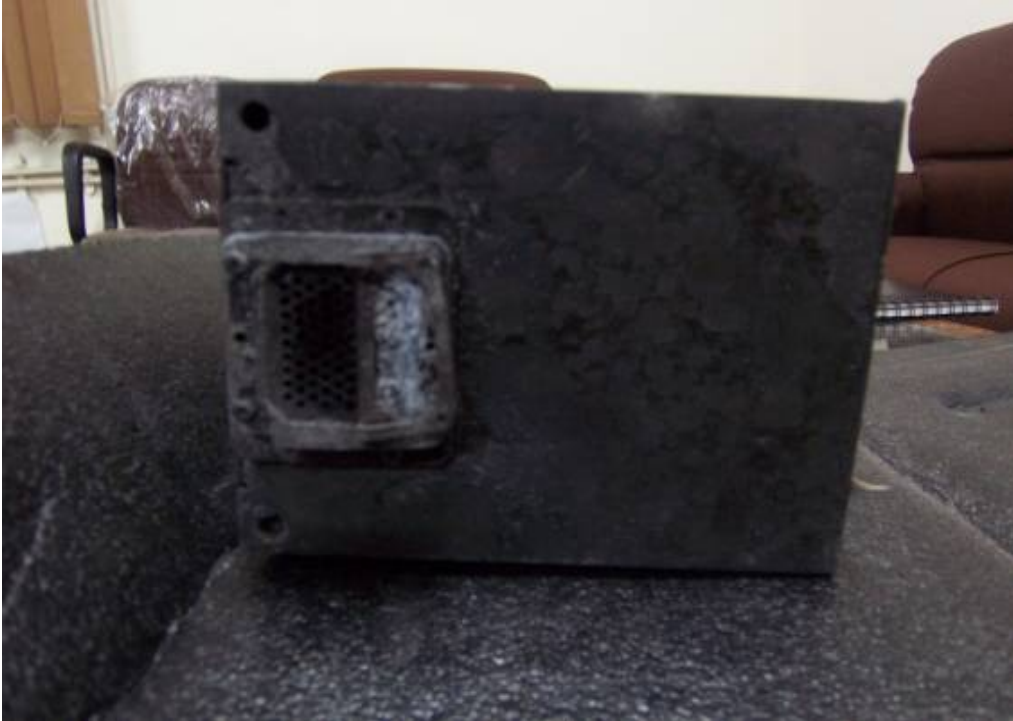
The CVR had sustained significant heat and fire damage to the exterior as shown below:-

Photo 5: Connector of the CVR Damaged Due to Fire

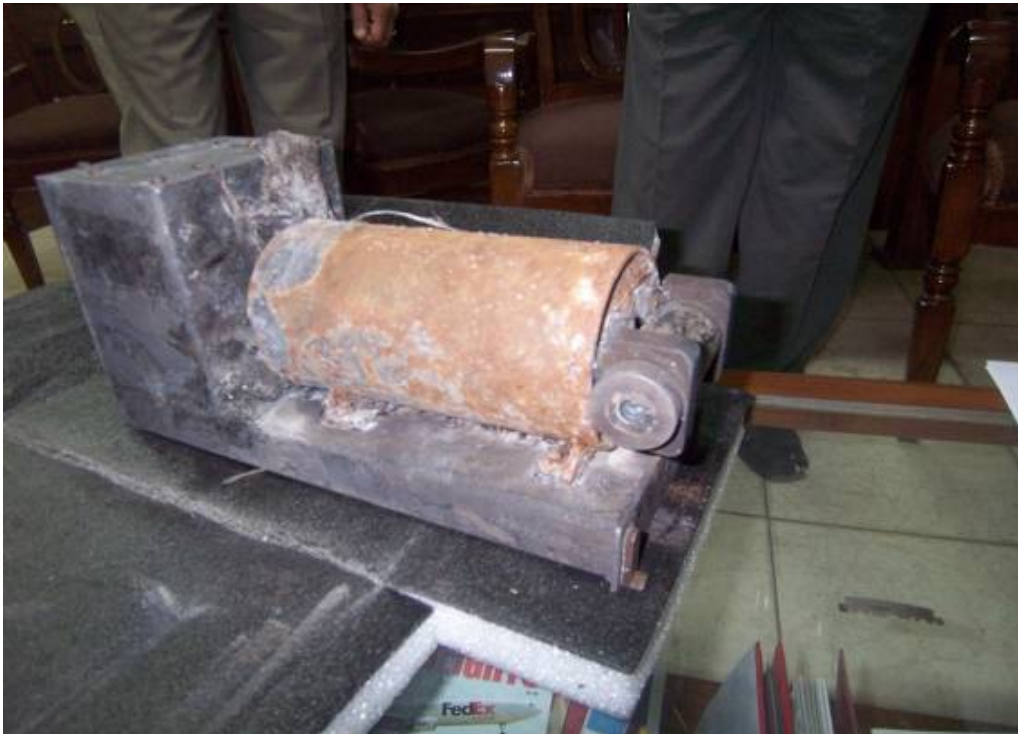
Photo 6: Damaged CVR Recovered From the Crash Site

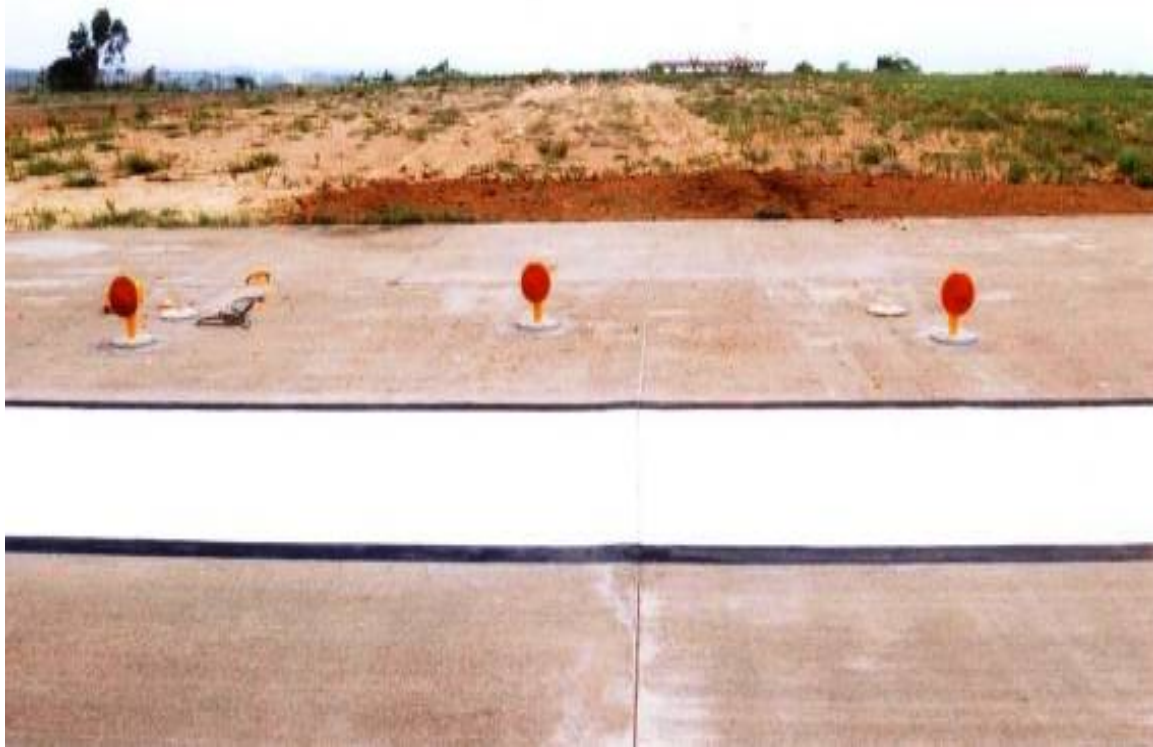
Thereafter, aircraft broke two runway edge lights towards the left of landing run (1st and third on left of centre line viewing from R/W 24). Then the aircraft overran the R/W 24 end and entered the Runway End Safety Area (RESA). It further broke five approach lights for R/W 06, in the RESA. In the RESA, wheel marks of all the three landing gears indicated that the aircraft was gradually turning towards the left. This is indicated in a rough Diagram 10, placed above.

Photo 7: End of Runway 24 (Far View)

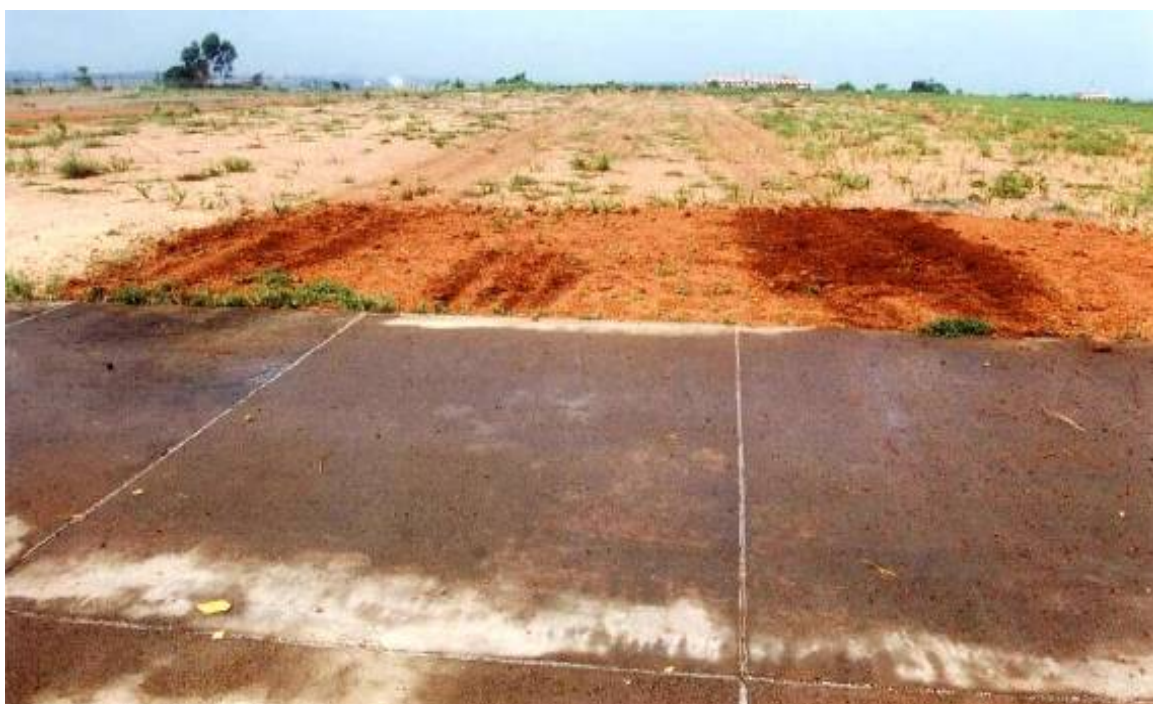
Photo 8: End of Runway 24 (Another View)

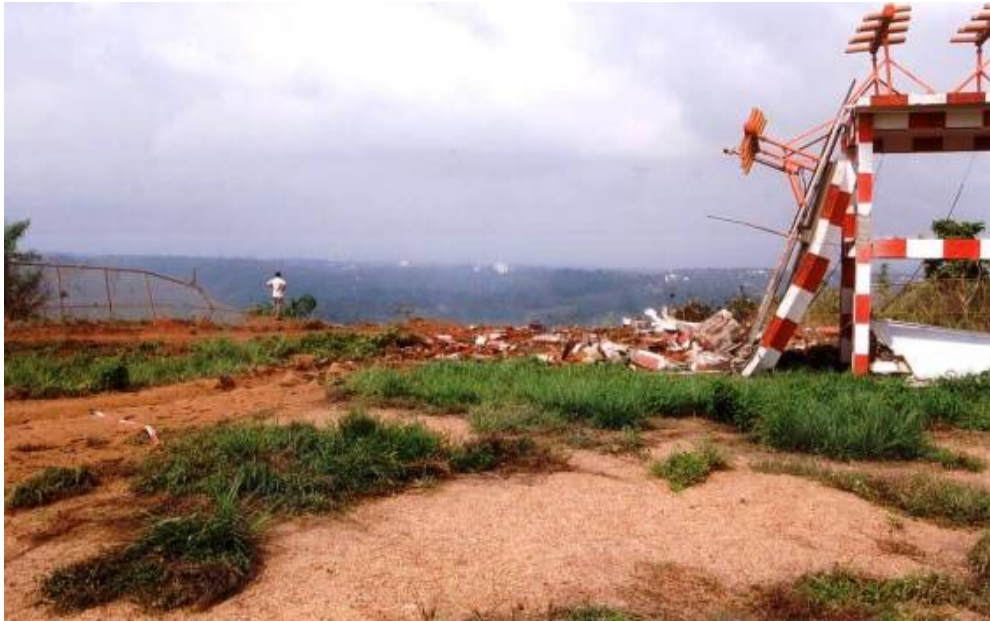
At a distance of 235 metres from R/W 24 end, the ILS localiser antenna had been mounted on a concrete structure. The out board portion of the right wing impacted this localiser mounting structure and got separated. The Right wing contacted two left pillars and the extreme left pillar collapsed. The second pillar from left, showed impact damage about 10 feet above ground. Outer portion of the right wing (WBL 616.75 to WBL 680.40) consisting of winglets was recovered at the localiser structure.

Photo 9: Broken ILS Mounting Structure Due to Impact of Wing

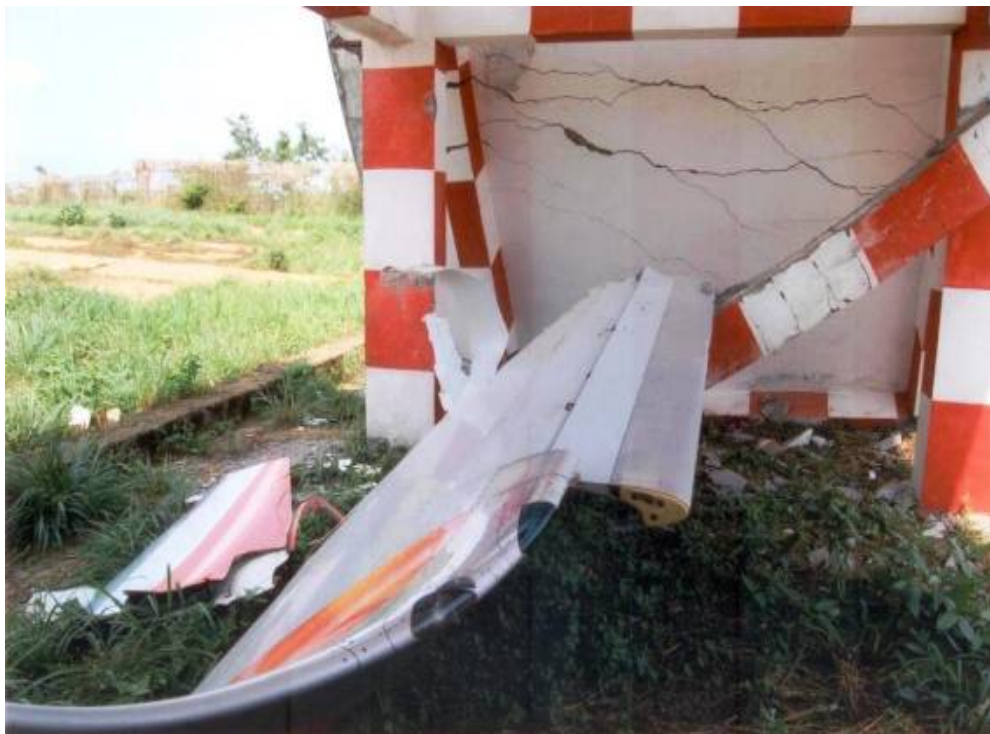
Photo 10: Broken Wing of Aircraft after Impacting the ILS Mounting Structure

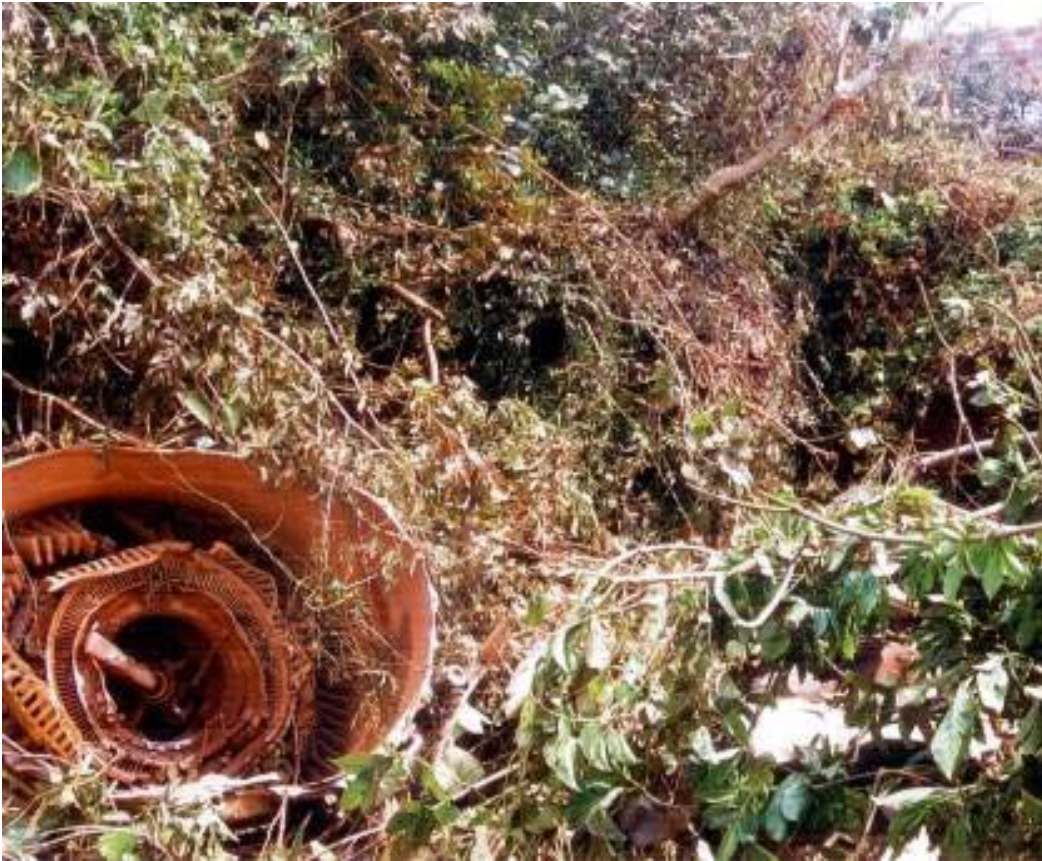
The aircraft then impacted the boundary fence and a portion of the Right wing (from WBL 71.24 to WBL 616.75) containing T/E Flap number 8, L/E Flaps and Slats, was found lying at the edge of the boundary. There were indications of fire visible in this area on the vegetation where the portion of the wing was found. Mangalore being a tabletop runway, the aircraft moved down along the slope of the hill after impacting the boundary fence. A portion of the Right wing, Right engine, Right main landing gear and few other structural parts separated from the aircraft in this area. Due to impact, component/parts of the Right engine also separated. Right engine fan frame, thrust reverser frame, core engine and associated components were recovered on the slope.

Photo 11: Right Engine lying on the Slope near End of the Airport Fencing

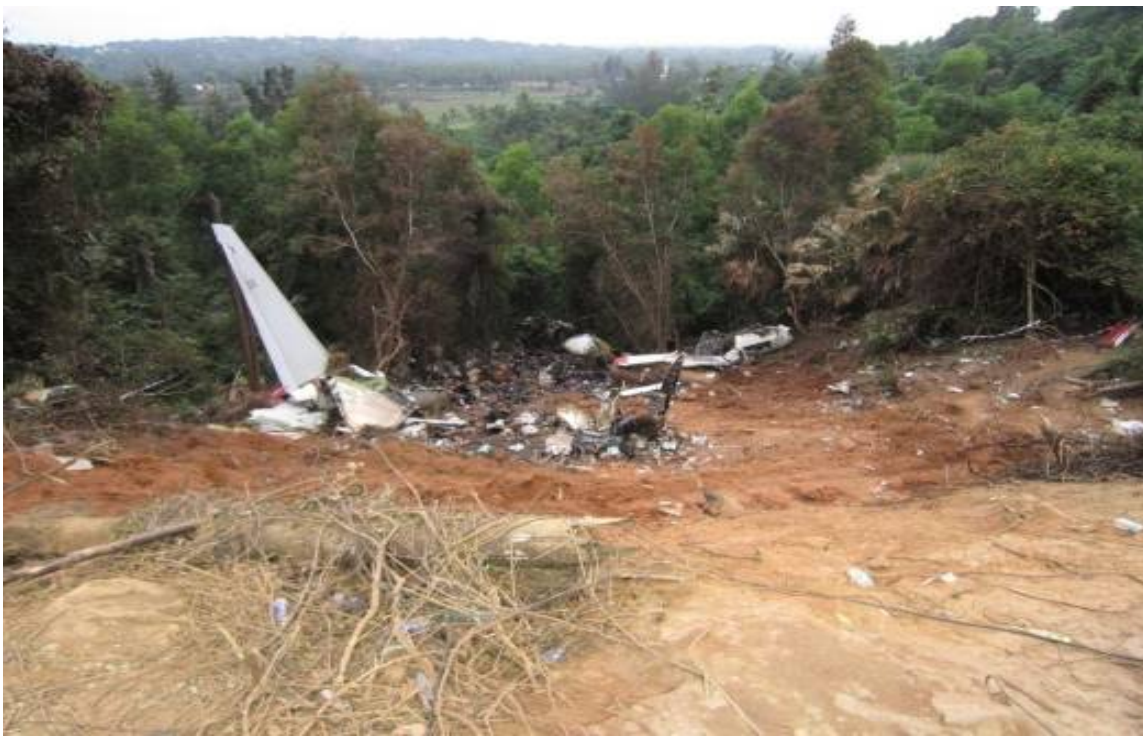
At the end of the initial down-slope, there was a road followed by a gorge. The aircraft entered the gorge and separated into three main portions. The aircraft caught fire and a large portion of the aircraft was consumed in the fire. Due to impact and fire, the aircraft was destroyed.

Photo 13: Gorge - The Final Resting Place of Wreckage

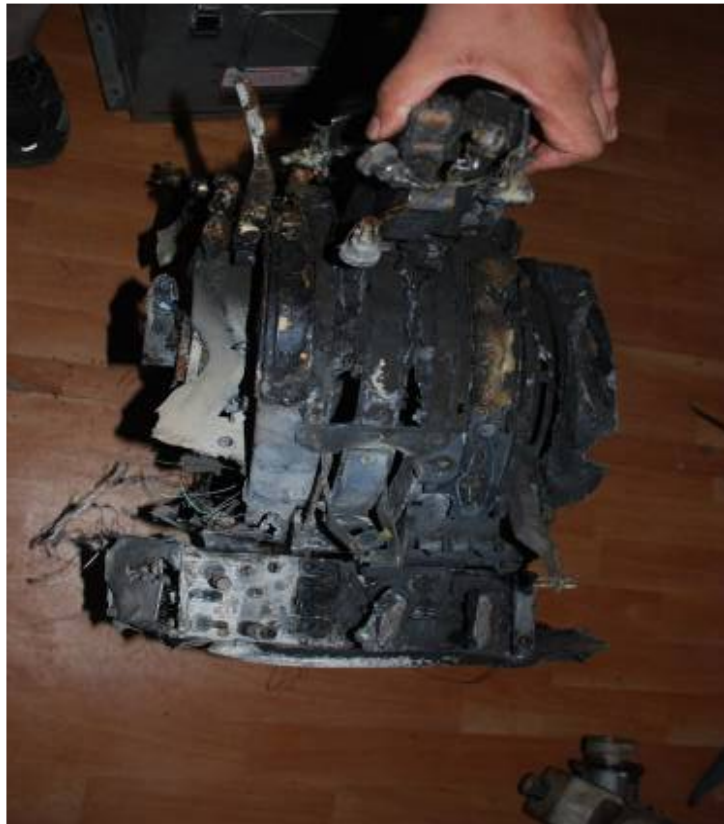
Photo 14: Control Stand

- Landing Gear Lever : Near Down Detent and Jammed
- Thrust Lever : Fully Forward
- Flaps : At Flap 40 detent
- Speedbrakes : Down Detent

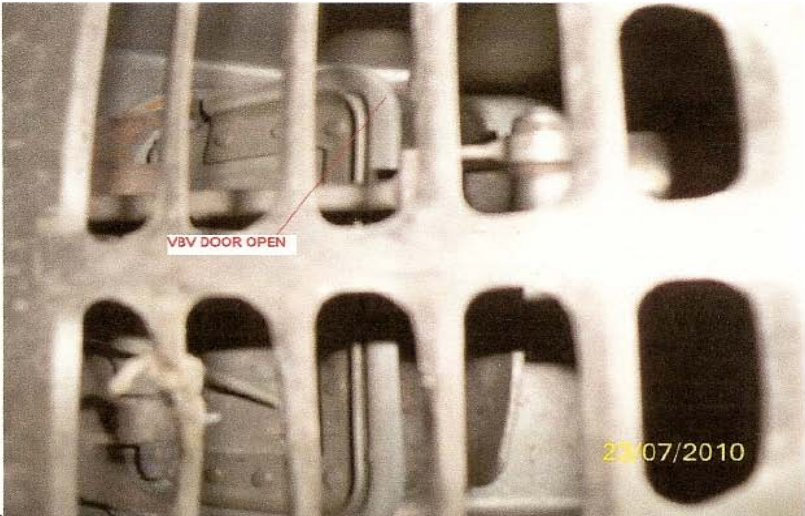
Variable Bleed Valve

1. Inlet cowl removed from the engine as instructed and engine installed on pedestals.
2. Inlet cowl found with impact damages at the forward end causing metal and composite material to liberate and enter into the gas path.
3. Fan frame and spinner cone found with deep dents.
4. All fan blades are found damaged. Some fan blades are observed torn with pieces missing.
5. The N1 and N2 spools of the engine could be rotated.
6. Exhaust nozzle and plug found with impact damages.
7. Variable bleed valves found fully open. Refer photograph below.

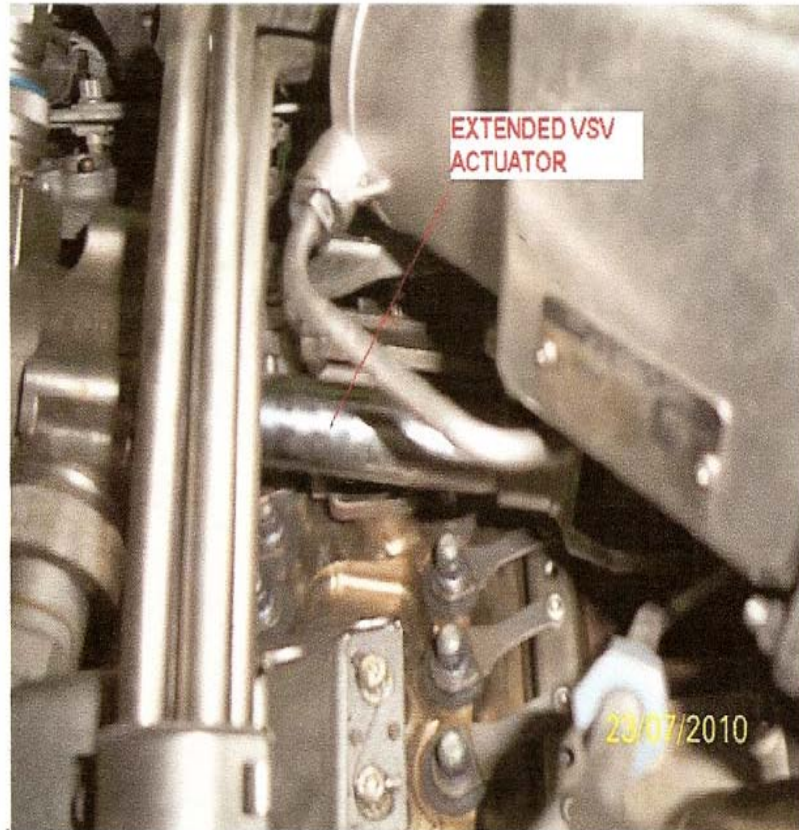
VSV Actuator.

8. Variable stator vane actuators found extended exposing approximately 3.500 inch of actuator piston rod. Refer photograph below.

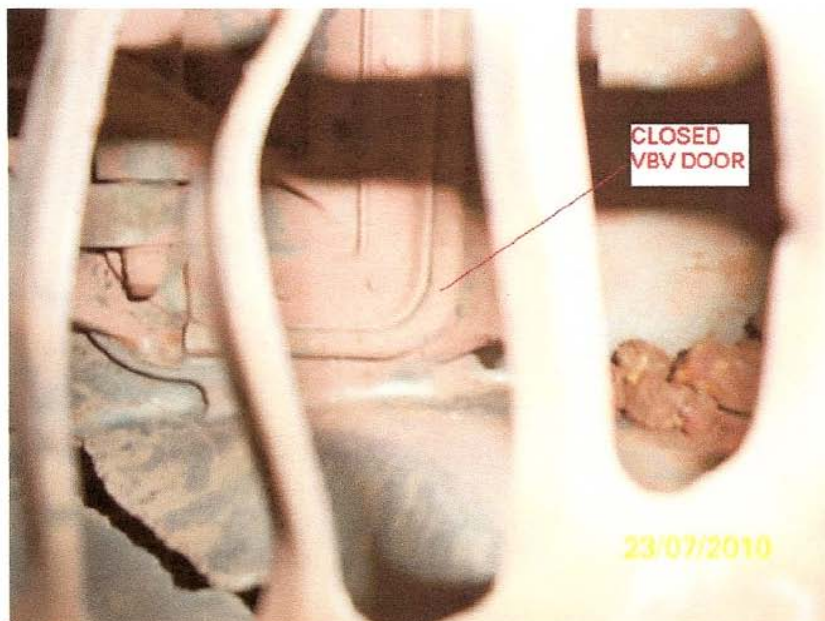
Variable Bleed Valve

1. Fan frame and turbine rear frame found distorted.
2. The forward and aft engine mounts found missing and thrust links found broken.
3. Fan frame observed twisted approx. 90 degree anti-clockwise looking from rear of the engine.
4. Low pressure turbine shaft found broken and the low pressure compressor with fan received as a separate disintegrated unit. All fan blades found sheared off near the root of the blade.
5. The N1 and N2 spool of the engine could not be rotated.
6. Accessory gear box and most of the accessories observed broken.
7. Variable bleed valve doors found closed, bleed ring area found totally distorted. Refer photograph below.

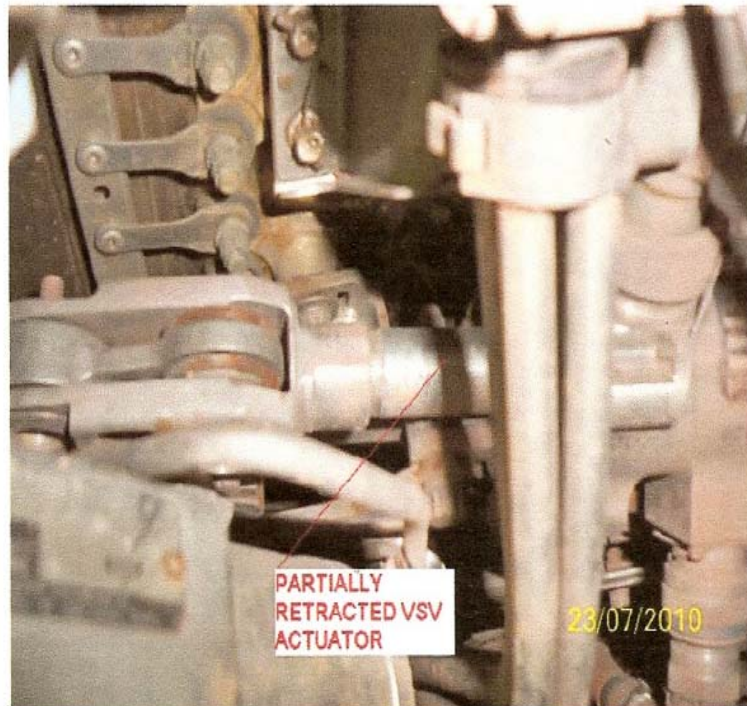
VSV Actuator.

8. Variable stator vane actuators found extended partially. Approximately 1.3 inch of actuator piston rod found extended. Refer photograph below.

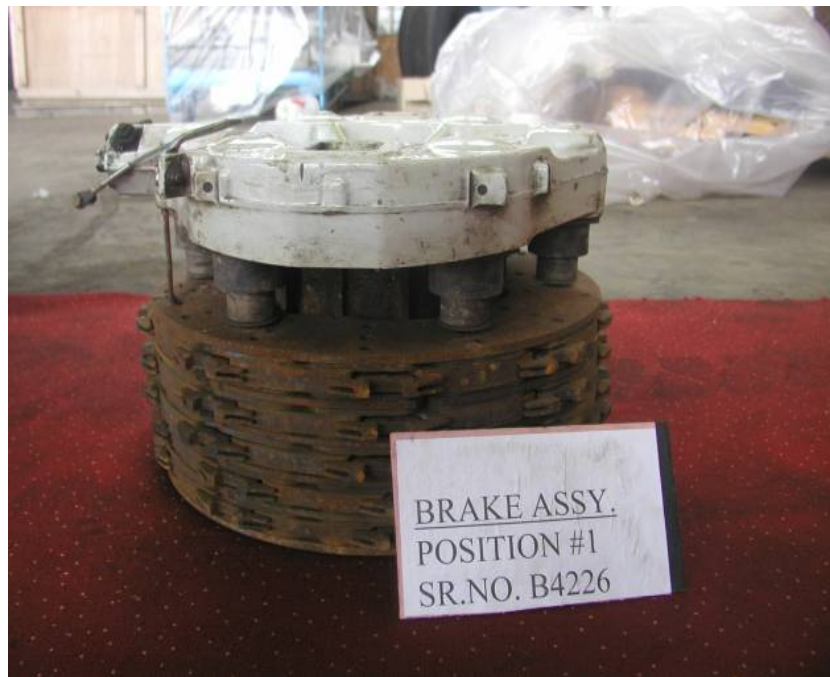
Photo 26: Brake Assembly Serial No B4226

Part No.	2612312-1	2612312-1	2612312-1	2612312-1
Brake Sr No.	B4226	B7423	B6221	B5382
Position	#1	#2	#3	#4
Installed on	12 th Sep 09	2 nd Sep 09	21 st Apr 10	2 nd Oct 09
Number of Landings	723	751	113	666
General Condition	No damage. (Rotors found free.)	No damage. (Rotors found free.)	No damage. (Rotors found free.)	Damage Observed on piston housing
Missing Parts	Nil	Nil	Nil	Qty. one indicator pin found missing
Hydraulic Leakage	No trace of hydraulic leakage	No trace of hydraulic leakage	No trace of hydraulic leakage	No trace of hydraulic leakage
Condition of Piston Housing	No damage observed	No damage observed	No damage observed	Damage observed at one location
Condition of Heat Stack	No damage observed	No damage observed	No damage observed	Found stuck in the wheel assembly S/N B10899
Indicator Pin	Both the pin in position	Both the pin in position. Out of which one found bent	Both the pin in position. Out of which one found bent	One pin in position and other found missing

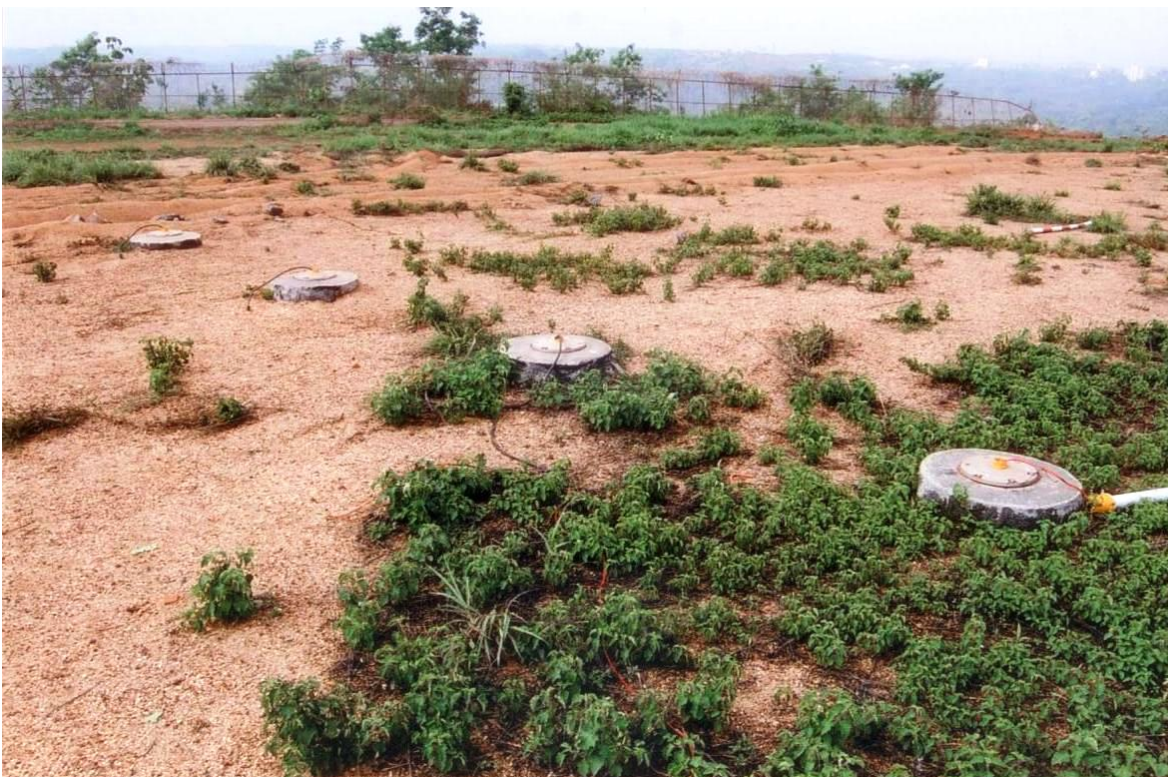
Inspection of RESA at Mangalore had revealed that at the time of accident, localiser antenna and some temporary concrete platforms for ILS calibration were located within RESA. It also lacked regular maintenance. The RESA did not have adequate sand refilled as the concrete mounting structure of approach lights were protruding above the surface. Also, there were shrubs and vegetation in RESA as evident from the photograph shown below. Regular ploughing of this area would have prevented such growth.

Photo 30: RESA for R/W 24 at Mangalore on the Day of Accident
