Marshalling issues, fatigue cited as risk factors in CP Rail Stoney Creek Bridge derailment

By **Aaron Orlando** - Jul 8, 2016

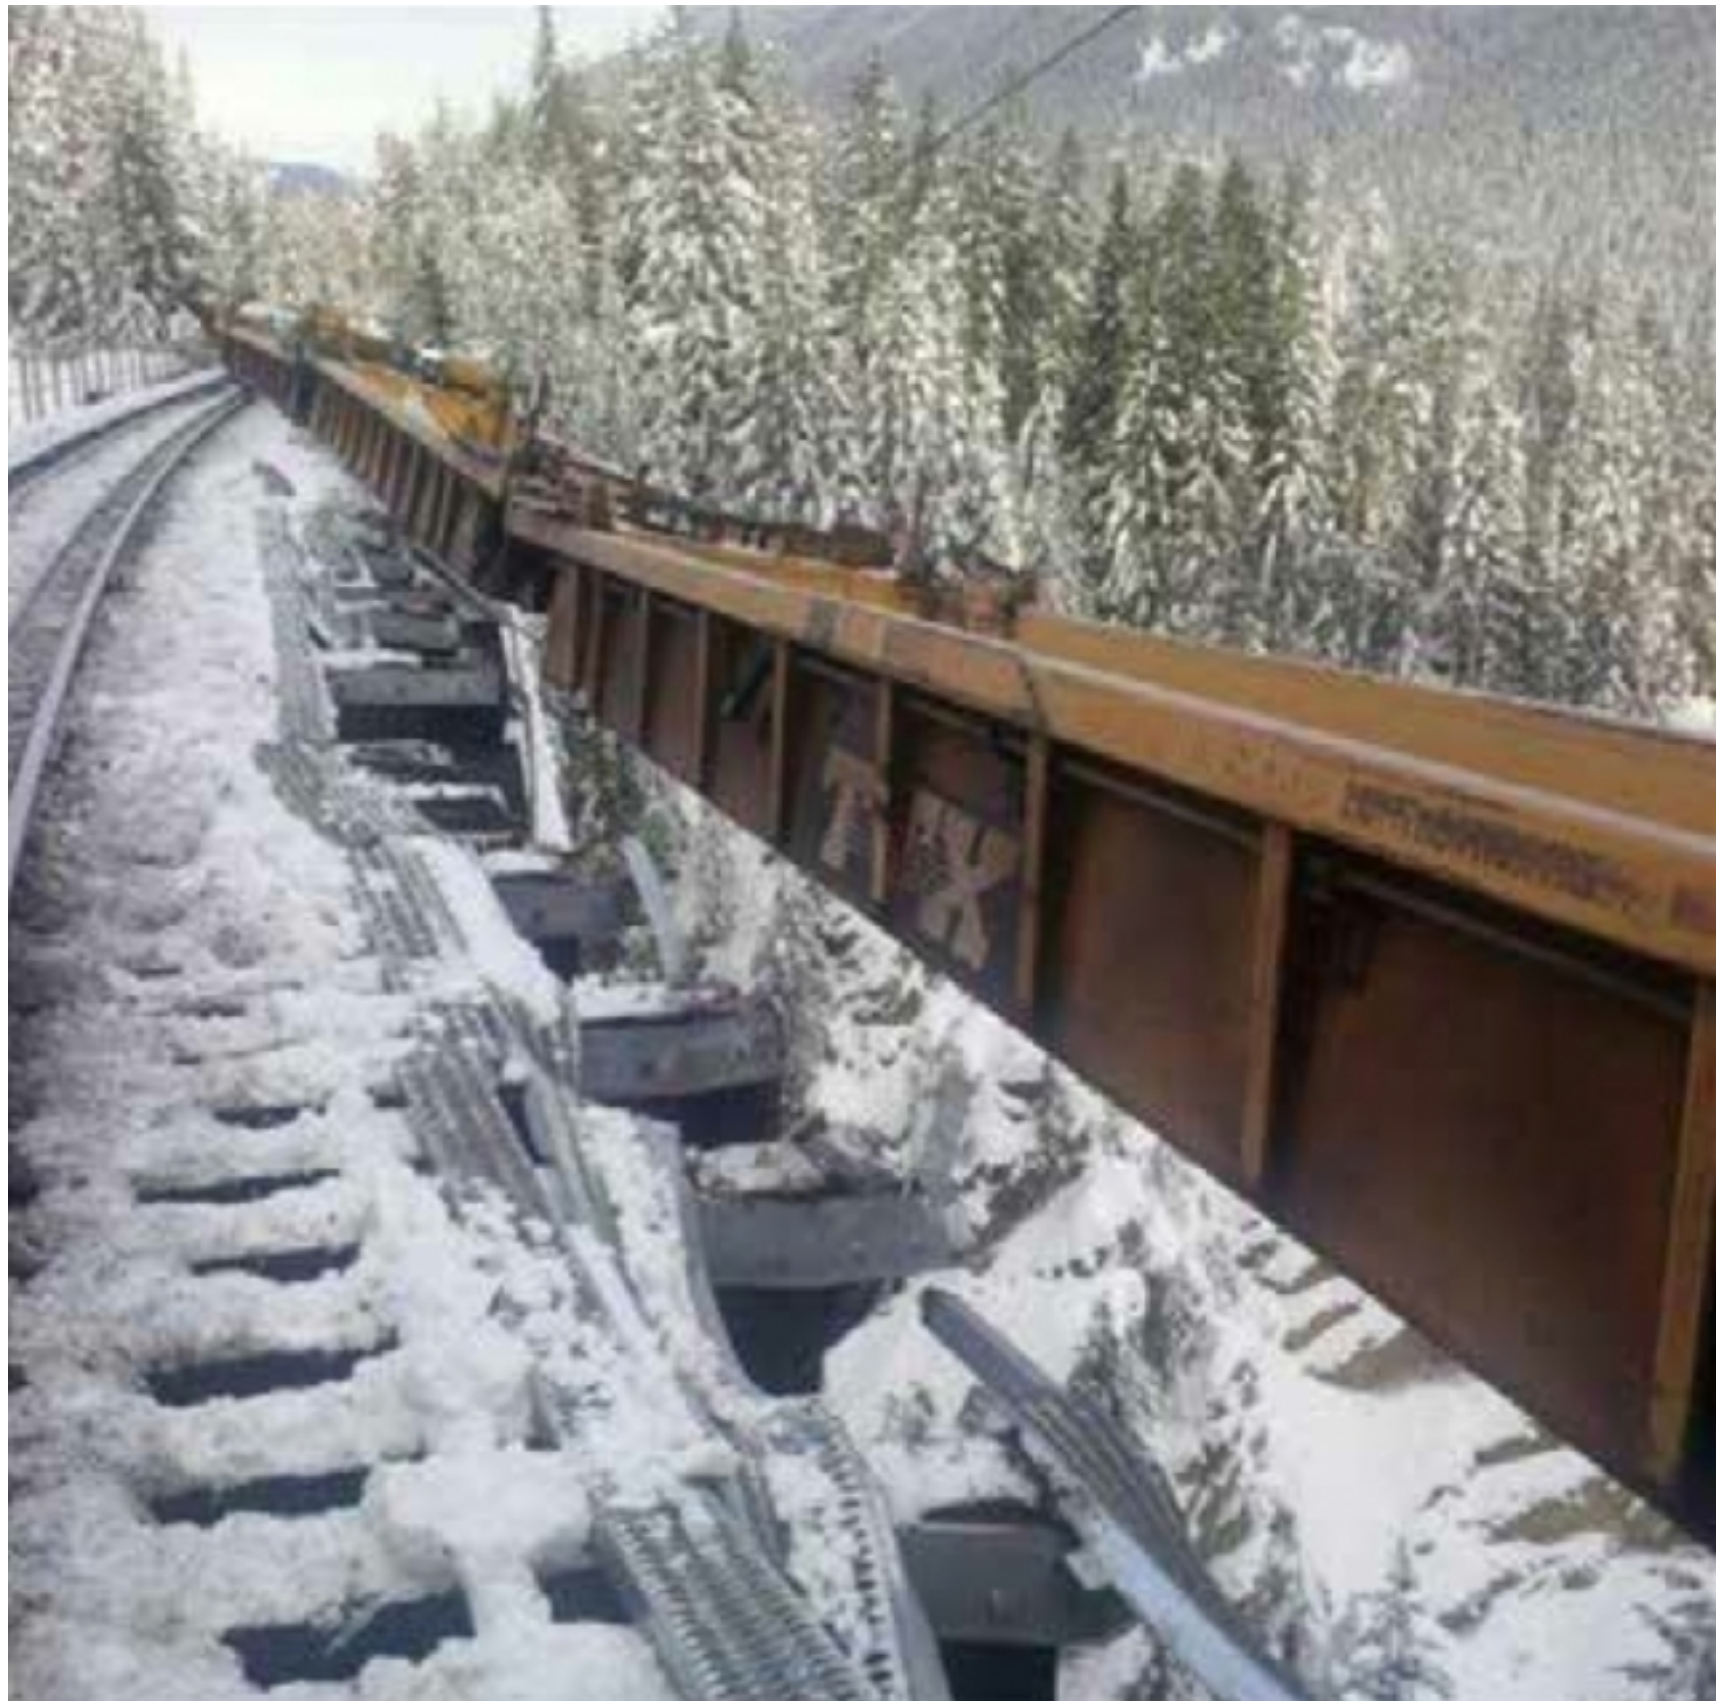
The report found that the derailment happened when several lighter cars on the train “stringlined” on the bridge. Basically, the empty cars were too light. When they were pulled through the curve at the bridge on an ascending slope, they popped off the rails and snapped into a straight line due to the force of being pulled between the engine and the weight of the cars downhill behind them. They were left hanging beside the 90-metre drop from the bridge to the canyon below. (See image above)

The TSB report says the westward train was originally scheduled to pass through the Mount Macdonald Tunnel, but due to congestion it was rerouted to the Connaught Tunnel, which has a steeper grade leading to the tunnel.

The westward track to the Mount Macdonald tunnel is rated TrAM 3, while the steeper track to the Connaught Tunnel — where the train was rerouted — is rated TrAM 5.

“The train crew did not, however, completely recheck the consist for TrAM Area 5 restrictions, as required by CP’s GOI,” the TSB reports states.

That put the train in violation of TrAM area 5 regulations, including maximum tonnage exceeded on four cars, and not enough tonnage on four cars.

The TSB report notes CP Rail has made changes to equipment that can automatically detect and alert for TrAM violations. The company has also changed their policy to require the director of rail traffic control to know and understand TrAM area zones in their territory.
