ISSUE 3, 2017

Flight Comment

VIEWS ON FLIGHT SAFETY

Director of Flight Safety

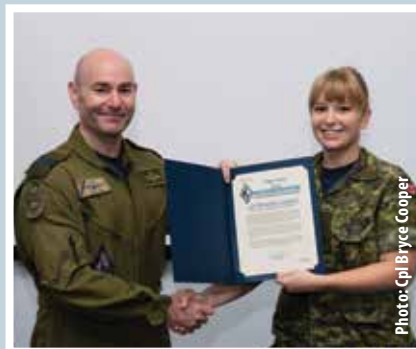
It was discovered that the 9 and 10 o'clock primary flaps, two secondary flaps and one outer flap had all sustained significant

damage which could render the VEN inoperable. If the aircraft had flown the air show routine in that condition, the differential thrust

On 24 April 2017, Cpl Lampard, an aviation technician was carrying out an inspection of a CF188 Hornet that was being prepared as the CF188 Air Show Demonstration jet. During her walk around, she inspected the afterburner section and noticed a very subtle but larger-than-normal gap between the Variable Exhaust Nozzle (VEN) primary and secondary seals. Cpl Lampard immediately raised a CF349 to initiate troubleshooting of the VEN section which revealed some alarming results.

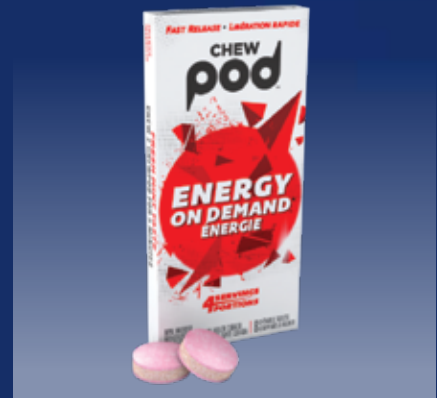
Figure 2. Caffeine Chew Pod.

On OP IMPACT, Flight Surgeons have been trialing caffeine "Chew Pod" ([figure 2](#)) as a pharmacological fatigue counter measure (PFCM) which tackles the alertness

The main active ingredient is caffeine and the tablet is coated with a mint flavouring to mask the bitterness of the caffeine. The recommended dose is two chewable tablets (100 milligrams (mg) of caffeine total) which is about the amount of caffeine in a cup of coffee. See [figure 3](#) for an approximation of caffeine equivalencies².

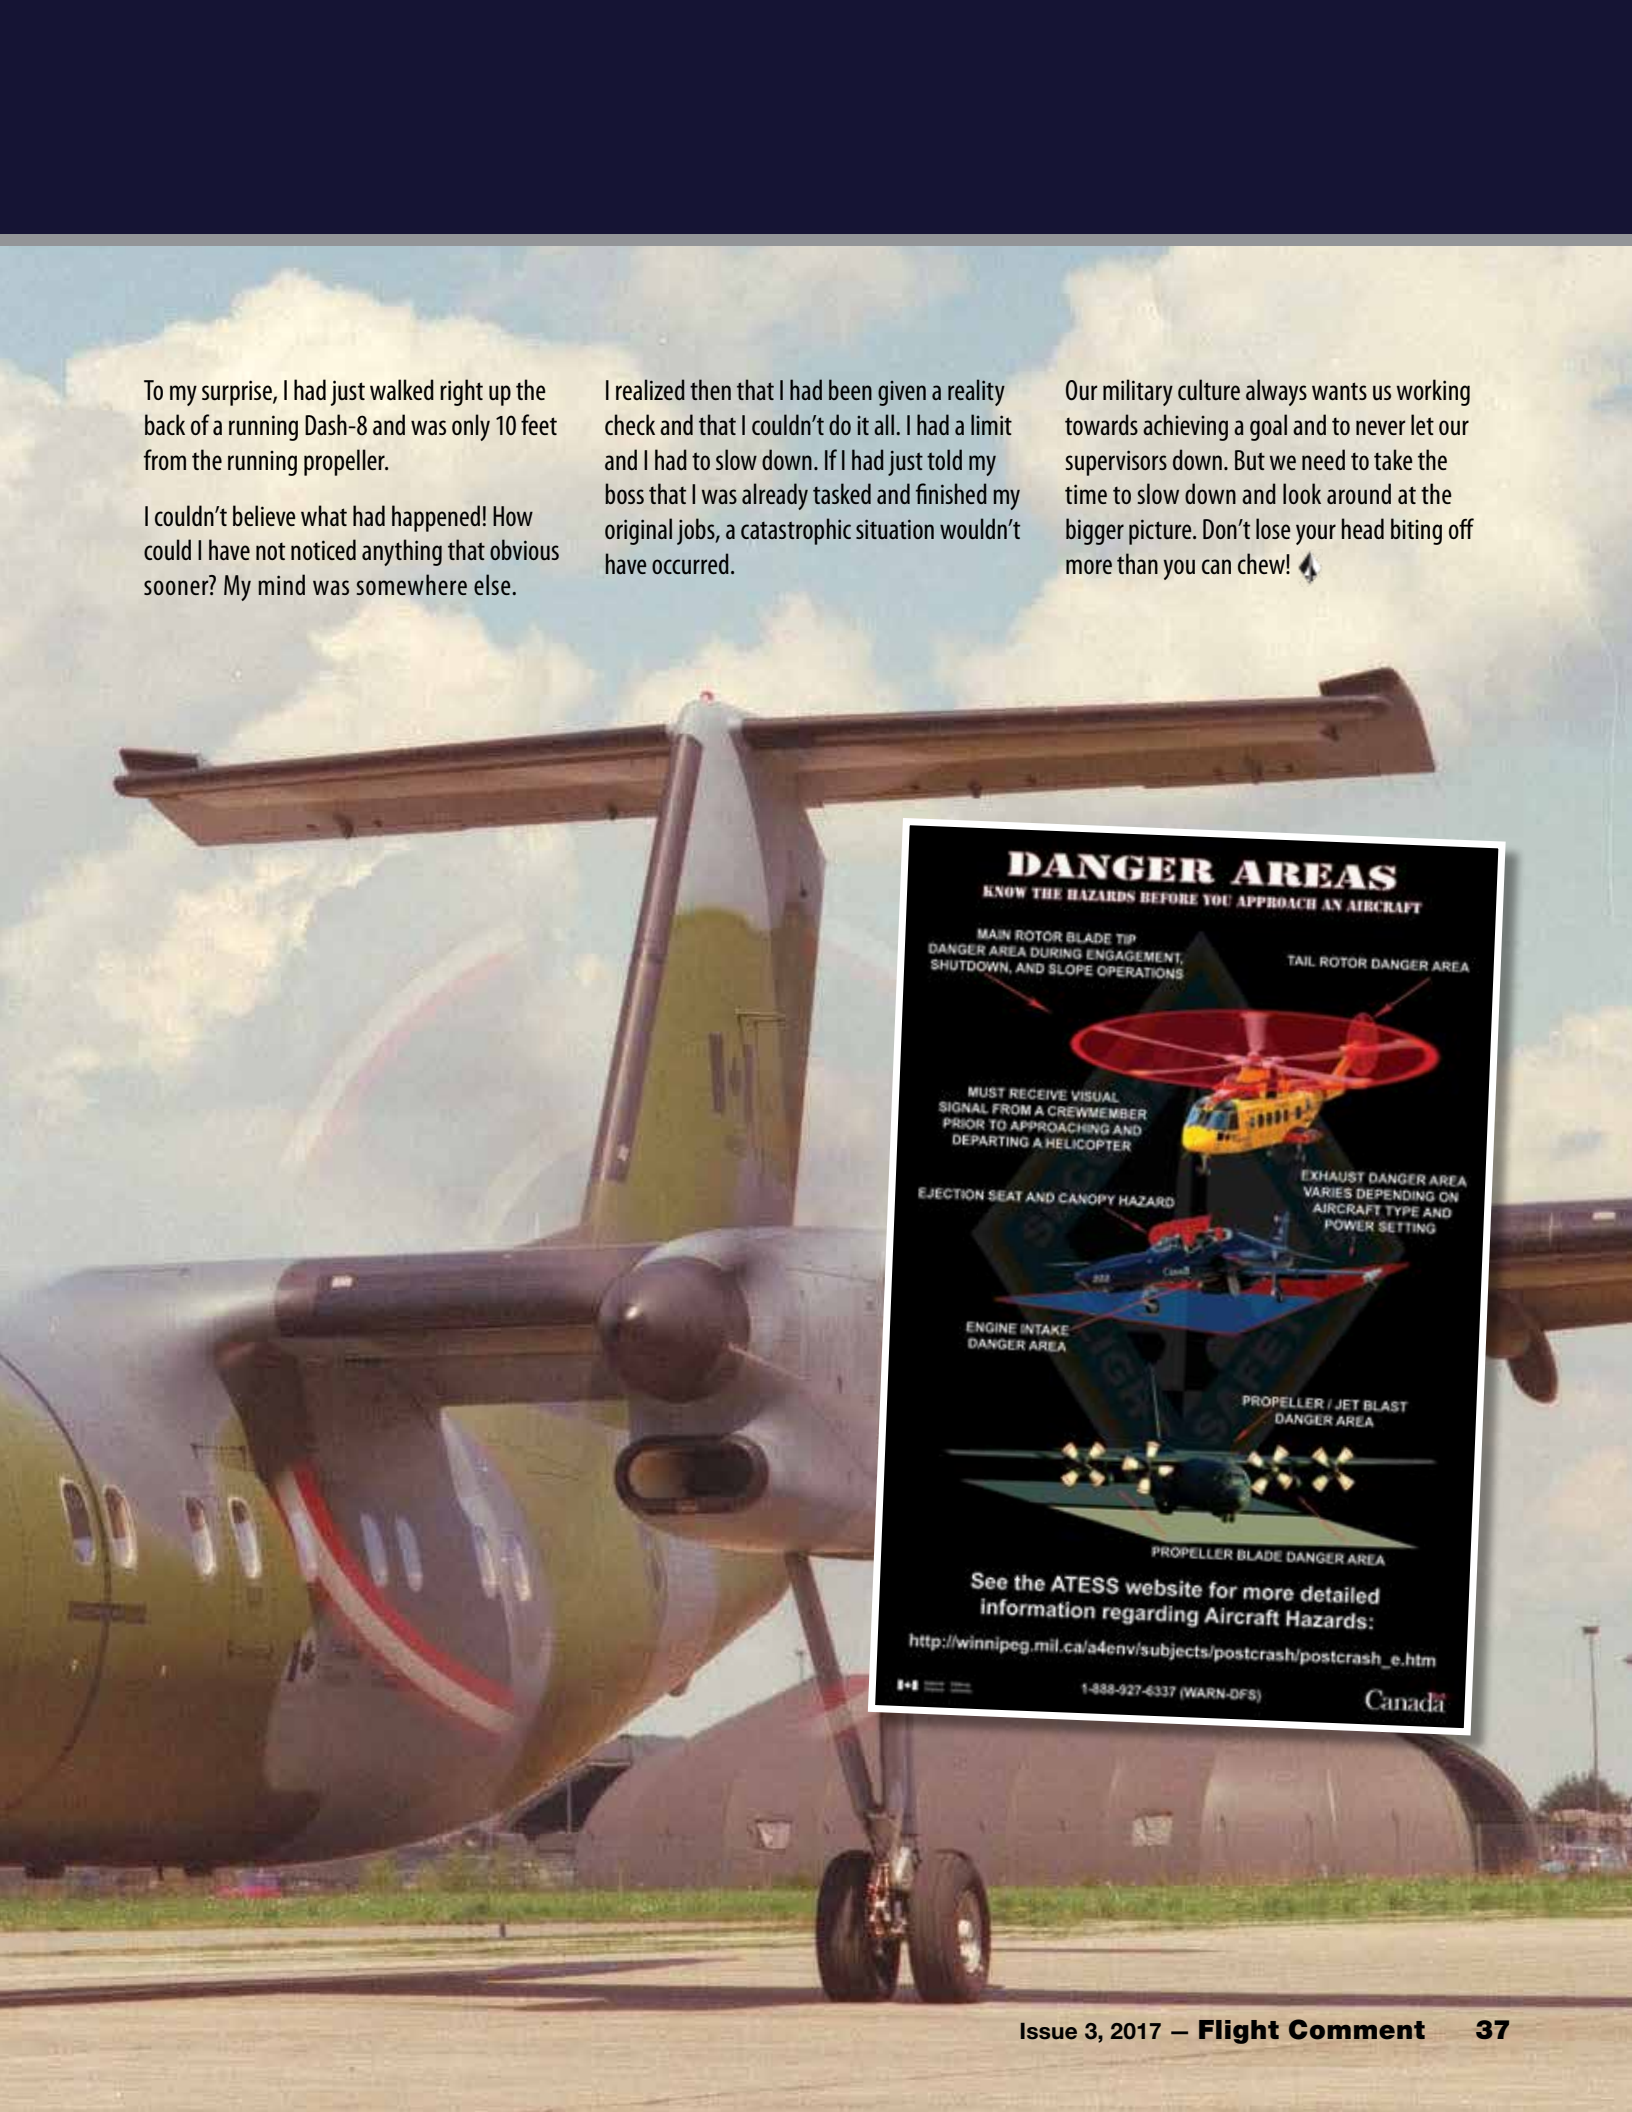
DANGER AREAS
KNOW THE HAZARDS BEFORE YOU APPROACH AN AIRCRAFT

- MAIN ROTOR BLADE TIP DANGER AREA DURING ENGAGEMENT, SHUTDOWN, AND SLOPE OPERATIONS
- TAIL ROTOR DANGER AREA
- MUST RECEIVE VISUAL SIGNAL FROM A CREWMEMBER PRIOR TO APPROACHING AND DEPARTING A HELICOPTER
- EXHAUST DANGER AREA VARIES DEPENDING ON AIRCRAFT TYPE AND POWER SETTING
- EJECTION SEAT AND CANOPY HAZARD
- ENGINE INTAKE DANGER AREA
- PROPELLER / JET BLAST DANGER AREA
- PROPELLER BLADE DANGER AREA
