**REPORT
ON
ACCIDENT TO AIR INDIA EXPRESS BOEING 737-800
AIRCRAFT VT-AXV ON 22nd MAY 2010
AT MANGALORE**

**AIR MARSHAL BN GOKHALE, PVSM, AVSM, VM (Retd)
FORMER VICE CHIEF OF AIR STAFF, INDIAN AIR FORCE**

**GOVERNMENT OF INDIA
MINISTRY OF CIVIL AVIATION**

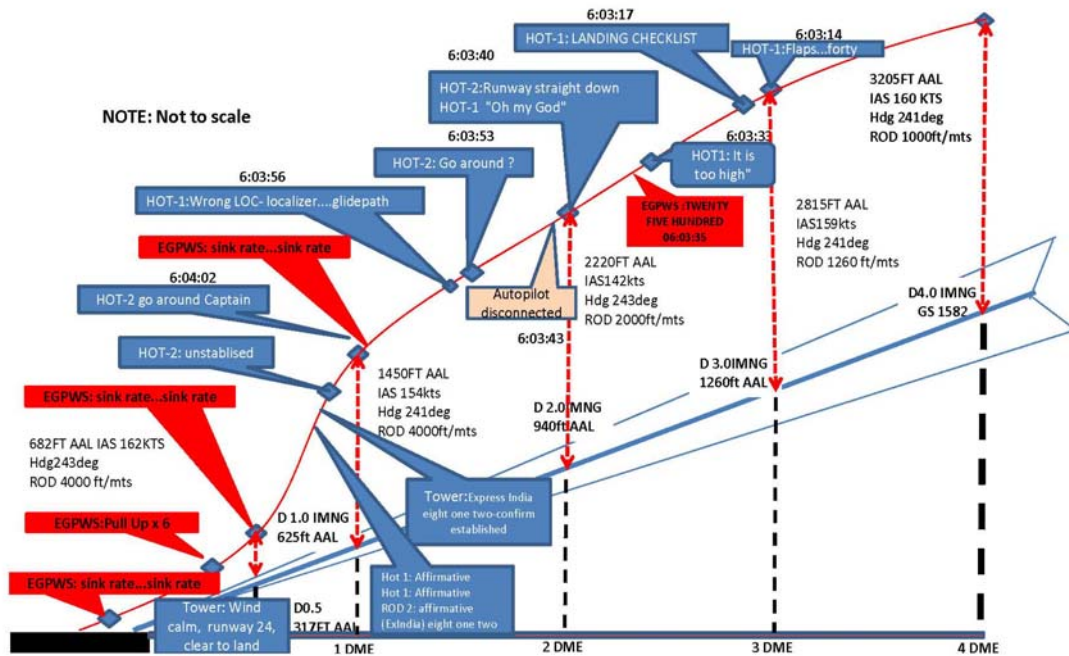
Despite the EGPWS warnings and calls from the First Officer to go around, the Captain had persisted with the approach in unstabilised conditions. Short of Touchdown, there was yet another (Third) call from the First Officer, this time on VHF Channel “GO AROUND CAPTAIN” followed by “WE DON’T HAVE RUNWAY LEFT” on the intercom. However, the Captain had continued with the landing and the final Touchdown was about 5200 ft from the threshold of R/W 24, leaving approximately 2800 ft of remaining paved surface.

Diagram 3: Approach Profile Including Salient Recordings from CVR

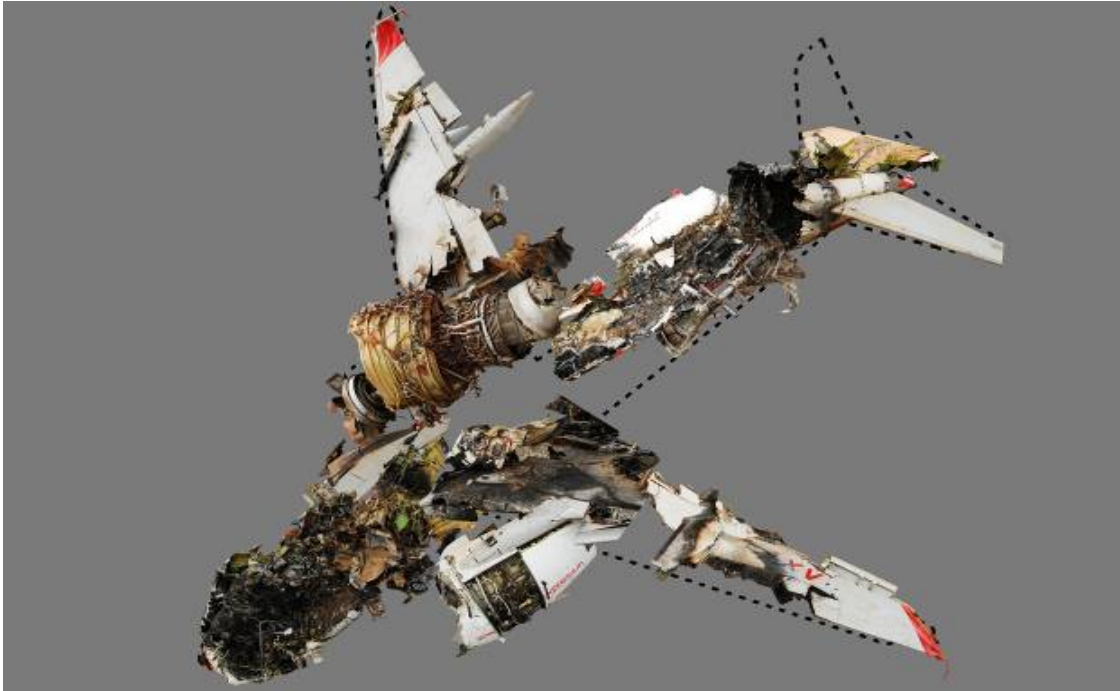
Photo 2: Photograph of the Re-arranged Wreckage

The entire wreckage from the crash site was later shifted to a secure area within the airport premises. For the ease of investigation, it was arranged in the shape of an actual aircraft as shown below: -

Under the supervision of Court of Inquiry, 63 components including both the engines were sent to the overhaul facilities of M/s Air India, Mumbai for detailed examination.

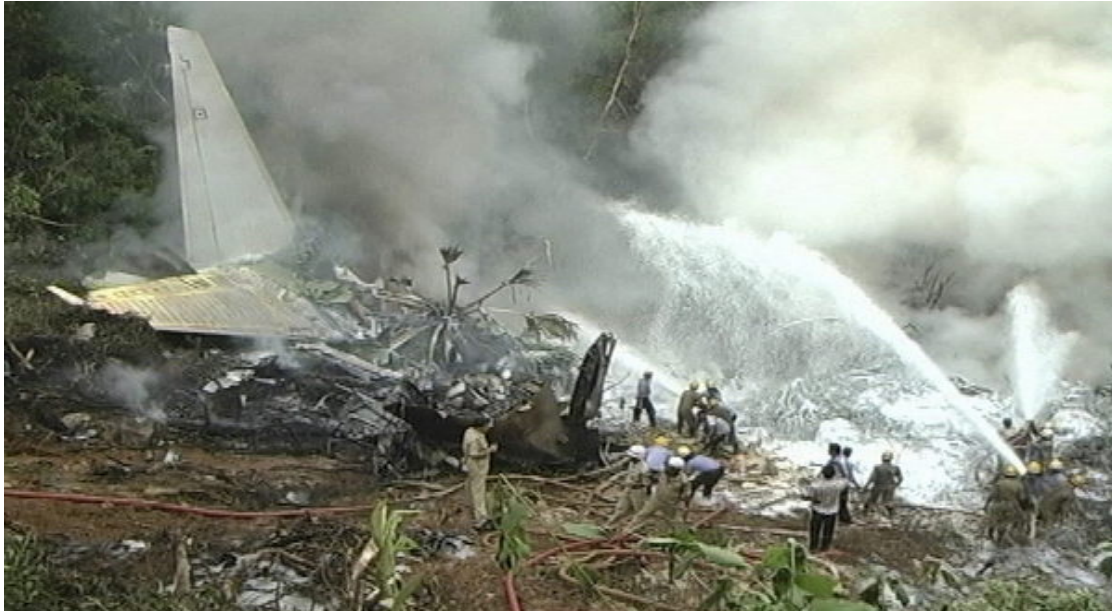
Photo 3: Rescue and Fire Fighting at the Crash Site

Although they reached as quickly as possible, the aircraft had already suffered major impact and a dense fire and smoke had engulfed the aircraft. Most of the other RFF crew, who were off duty and at residences near by, also rushed to the crash site with all available RFF vehicles and ambulances. With great motivation and involvement, the fire was partly brought under control by the AAI staff in the next 30-40 minutes by which time the Civil Fire Tenders had also joined fire fighting at the crash site. The entire fire could only be brought under control in about 2 hours.

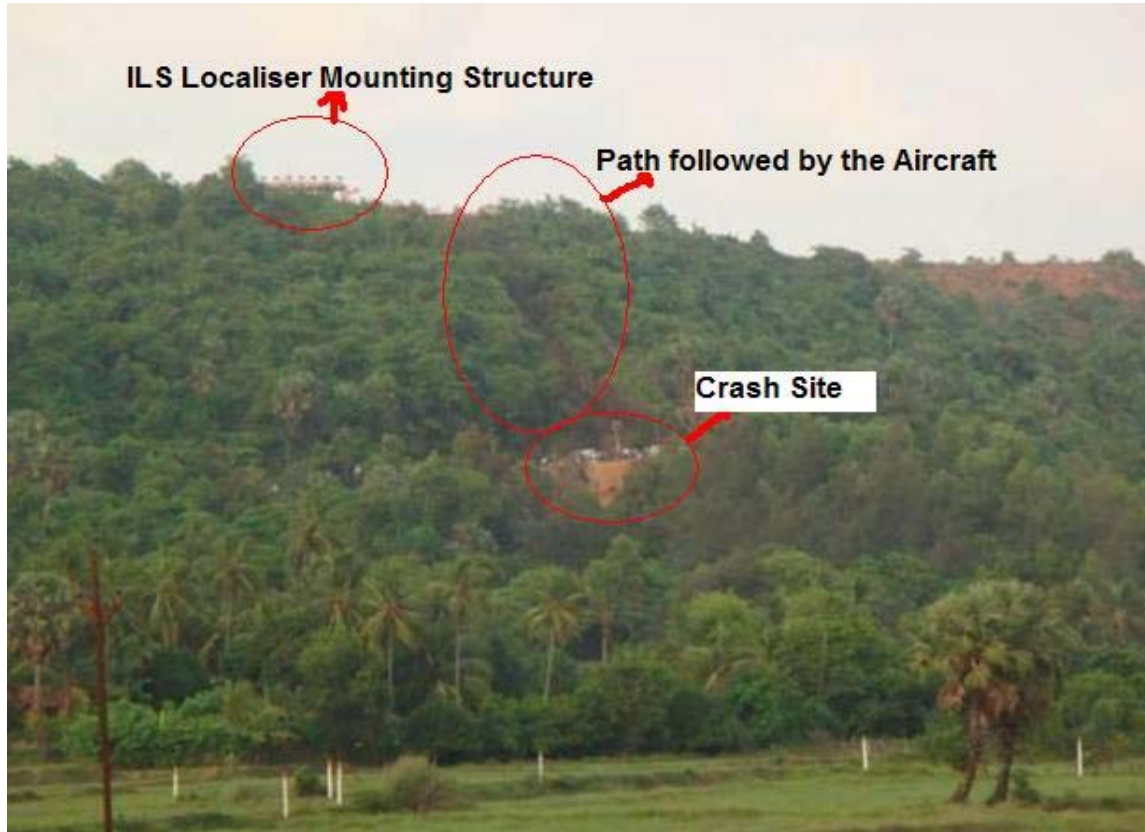
At the end of the initial down-slope, there was a road followed by a gorge. The aircraft entered the gorge and separated into three main portions. The aircraft caught fire and a large portion of the aircraft was consumed in the fire. Due to impact and fire, the aircraft was destroyed.

Photo 12: View of Path Followed by the Aircraft from Localiser Structure

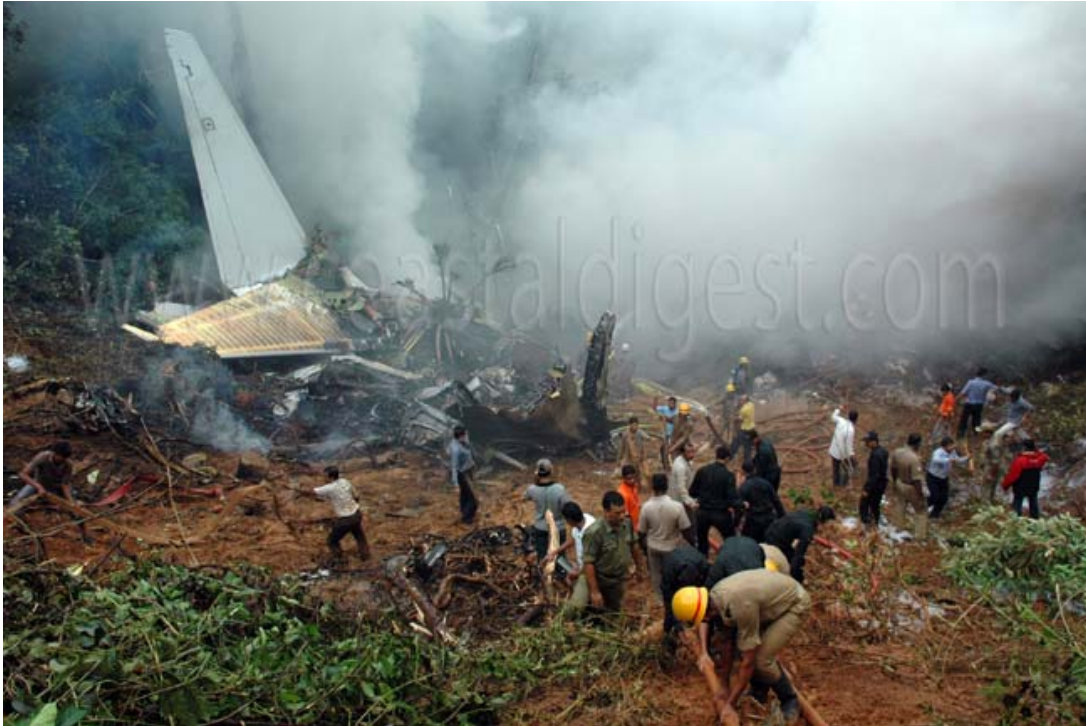
This RFF reached to the edge of the slope close to airfield perimeter and tried to throw water and foam towards the aircraft. But, the crash site was out of its range. It, therefore, extinguished fire of all parts of the right wing, which had broken off after the impact with ILS structure.

Photo 15: RFF Crew Laying Hoses to Fight the Fire

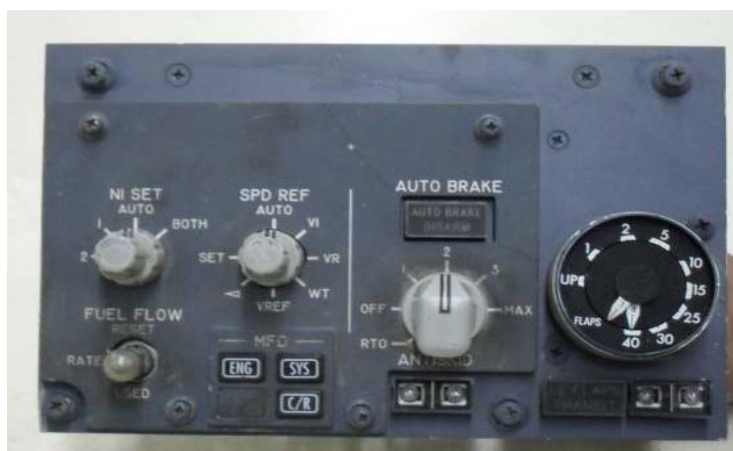
Photo 16: Brake Selector Panel and Flap Position Indicator

Part No.	233A2224-5 / 2061-15-1
Sr. No.	D02583 / 2806
CMM	73-31-01
General Condition	Connector plate bent at J1 connector. L2 Anti Skid Indicator & L4 indicator damaged. Flap position front glasses broken.
S/W Position	N1 Set – Auto SPD Ref – Auto Auto brake indicator – 2 S2 Fuel flow S/W – Rate R Flap position indicator – Flaps

Flap lever was seen on the Flap 40 detent, which corresponded to RH Flap position indicator needle. This also corresponded to the fully extended Jackscrews.

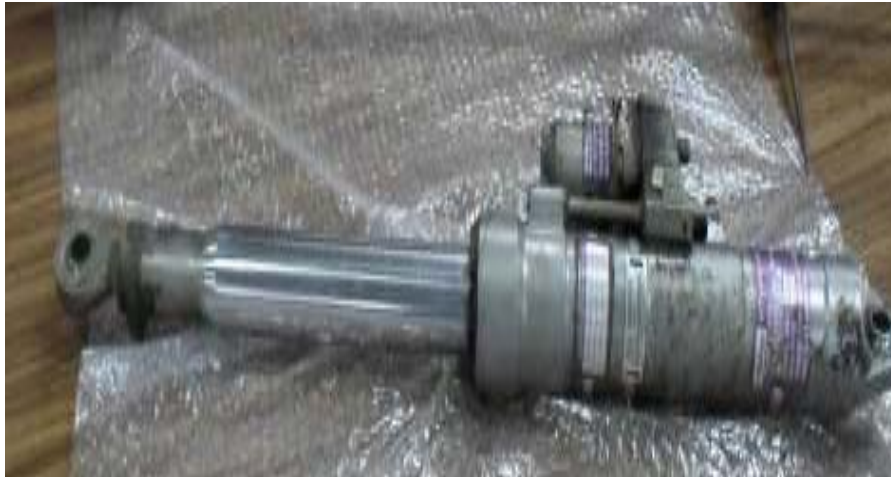
Photo 17: Leading Edge Flap Actuator

Part Number	382000-1001
Serial Number	10161
Position	# 2.
CMM	27-80-05
Total length	“L” :- 26.2 Inches (Between bearings centre)
Findings	(a) Actuator position - extended corresponding to flap extended. (b) Physical condition is ok. (c) No parts missing.

All the Leading Edge Flap / Slat actuators were found in the extended position, which correspond to the flap lever position of 40°. Therefore, it could be concluded that all Leading Edge devices had operated as per the cockpit input.

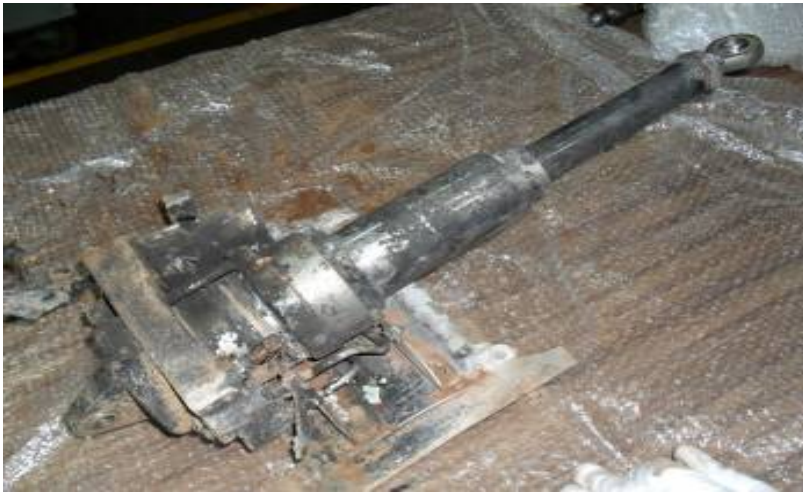
Photo 18: Leading Edge Actuator Assembly

Part No.	381800-1005
Serial No.	23103.
Position	# 07, LE SLAT.
CMM	27-80-06
Total length	"L":- 22.0 in. (From Piston eye end to Body eye fitting centre.)
Findings	(a) Actuator position-extended corresponding to flap extended (b) Full body found burn marks. (c) Piston rod is intact.

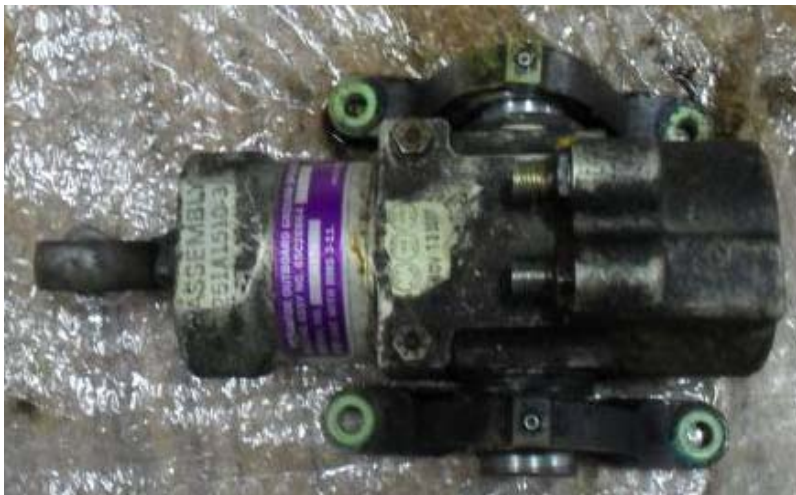
Photo 19: Ground Spoiler Actuator

Part No.	65C2684-3/251A1510-3
Serial No.	EFS08654
Position	#12
CMM	27-62-71
Findings	(a) Actuator position- Retracted corresponding to Spoiler retracted. (b) No parts are missing. (c) Actuator found burn marks.

From the DFDR read out, it is clear that speedbrakes were deployed in flight from 06:04:02 to 06:04:22 hours IST and again on landing from 06:04:42 to 06:04:54 hours IST. Thereafter, it remained retracted till the end. From the above, it can be seen that speedbrakes had responded correctly to the commands.

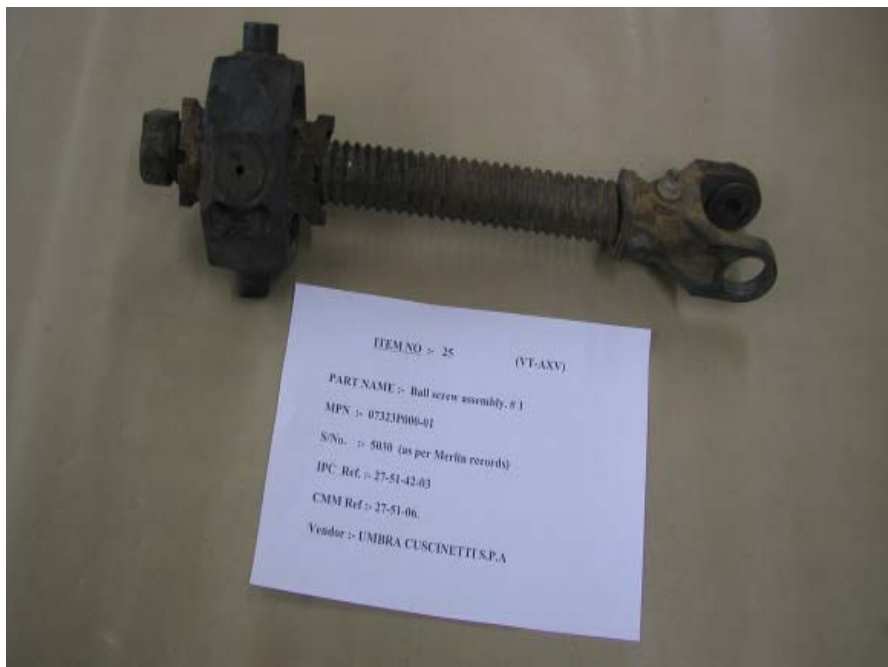
Photo 20: Trailing Edge Flap Ball Screw

Part No.	07323P000-01
Serial No.	5030
IPC Ref.	27-51-42-03
Total length	"L" :- 20.00 Inches (stop end to Centre of yoke end bushed hole)
Findings	(a) Ball nut & Gimbals assy. found in flap fully extended position

Flap handle was found in the 40 detent. Trailing Edge Flap Jack Screws were found in the fully extended position, which corresponded to the fully extended position of the flap. From DFDR data, it was seen that flap lever and the flap surface were in 40 degree position in flight from 06:03:23 to 06:04:16 hours IST. Thereafter, while the flap lever continued to remain in the 40 detent, the surface had retracted to 30 degree between 06:04:17 and 06:04:37 hours IST due to increase in speed of the airplane. Flap surface was again extended to 40 degrees from 06:04:38 hours IST till the time of the accident. From the above, it could be implied that Flap system had responded correctly to the commands.

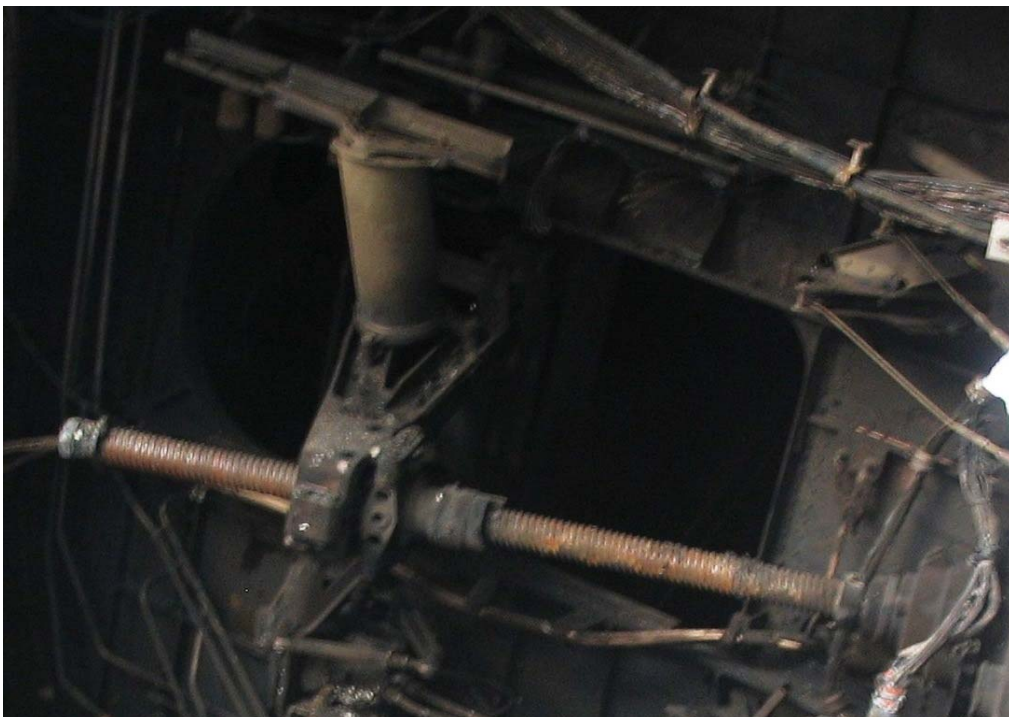
Photo 21: Photograph of Stabiliser Jack Screw

The dimension 'B' as given in the Diagram No 5 was measured from the debris. It was found to be 37 inches. This corresponds to 6 units of Stabiliser Trim. For airplane full nose 'UP' position, the dimension 'B' should be 21.32 inches and for full nose 'DOWN' condition, the dimension should be 45.84 inches. From this observation, it could be inferred that the horizontal Stabiliser was in nose 'DOWN' position, which is the landing configuration.

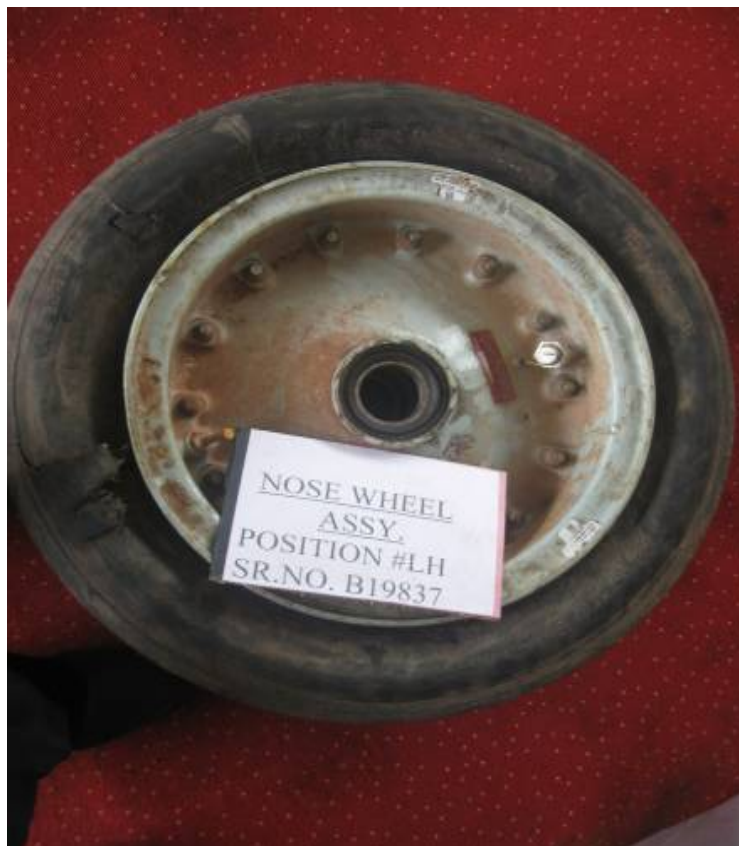
Photo 27: Nose Wheel and Tyre Assembly

Part No.	277A6000-453	277A6000-453
Serial No.	B19837	B 18600
Position	Left Hand	Right Hand
Date installed	25 th April 2010	19 th April 2010
Landings done	113	117
Tyre Findings	Tyre cuts noticed on sidewall towards O/B side at 2 locations.	Tyre cuts noticed on sidewall towards O/B side at 2 locations (2"x2" side wall tyre piece missing)
Hub Assembly Findings	All tie bolts found intact Pressure relief valve found intact Wheel bearing and seal found intact. No damage noticed on I/B and O/B HUB externally.	All tie bolts found intact. Pressure relief valve found intact Wheel bearing and seal found intact No damage noticed on I/B and O/B HUB externally.

From the above, there was no indication of any defect on both the nose wheel assemblies prior to the accident.

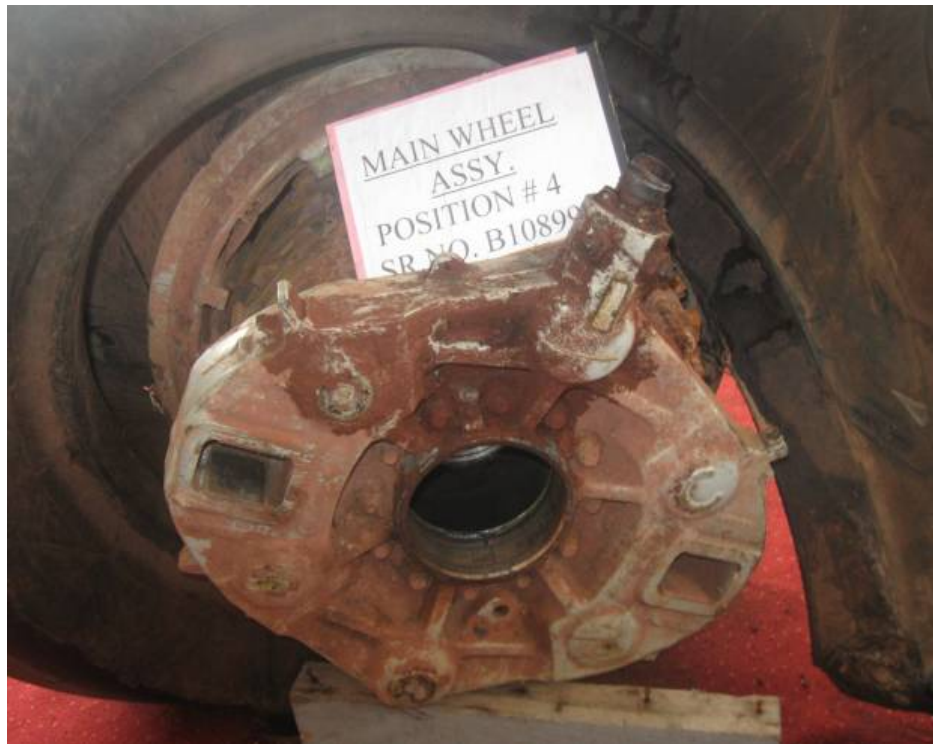
Photo 28: Main Wheel and Tyre Assembly

Part No.	277A6000-204	277A6000-204	277A6000-204	277A6000-204
Serial No.	B9061	B14941	B8266	B10899
Position	# 1	# 2	# 3	# 4
Date of Installation	07.05.2010	18.04.2010	01.05.2010	18.05.2010
Landings done	63	135	79	14
Tyre Findings	a) Deep cut noticed at 2 locations on sidewall. b) Burn marks noticed on tread area approx 2 feet by 10 inch on crown area. c) Wheel assy. Holding 30 PSI pressure	Tyre found burst and burn at about ¾ of tyre crown area	a) Tyre burst b) Tyre found damaged at four locations c) Tyre cut noticed about 4 feet due to burst towards I/B side	a) Brake and wheel found jammed b) Tyre burst c) Burn marks noticed on tread area approx 2 feet by 10 inch on crown area
Hub Assembly Findings	a) All tie bolts found intact b) All fusible plugs found intact c) No damage noticed on heat shields and keys d) Pressure relief valve found intact e) Wheel bearing and seal found intact f) No damage noticed on I/B and O/B HUB externally	a) All tie bolts found intact b) All fusible plugs found intact c) No damage noticed on heat shields and keys d) Pressure relief valve found intact e) Wheel bearing and seal found intact f) Minor Damage noticed on I/B and O/B HUB externally	a) All tie bolts found intact b) All fusible plugs found intact c) Minor damage noticed on heat shields and keys d) Pressure relief valve found intact e) Wheel bearing and seal found intact f) No damage noticed on I/B and O/B HUB externally.	a) All tie bolts found intact b) All fusible plugs found intact. c) No damage noticed on heat shields and keys d) Pressure relief valve found intact e) Wheel bearing and seal found intact f) Minor damage noticed on I/B and O/B HUB externally.

The analysis of the Main Wheel showed no pre-existing defects. Three tyres were burst due to post impact damage. Number 1 Wheel Assembly, which was intact, was holding 30psi pressure at the time of examination.

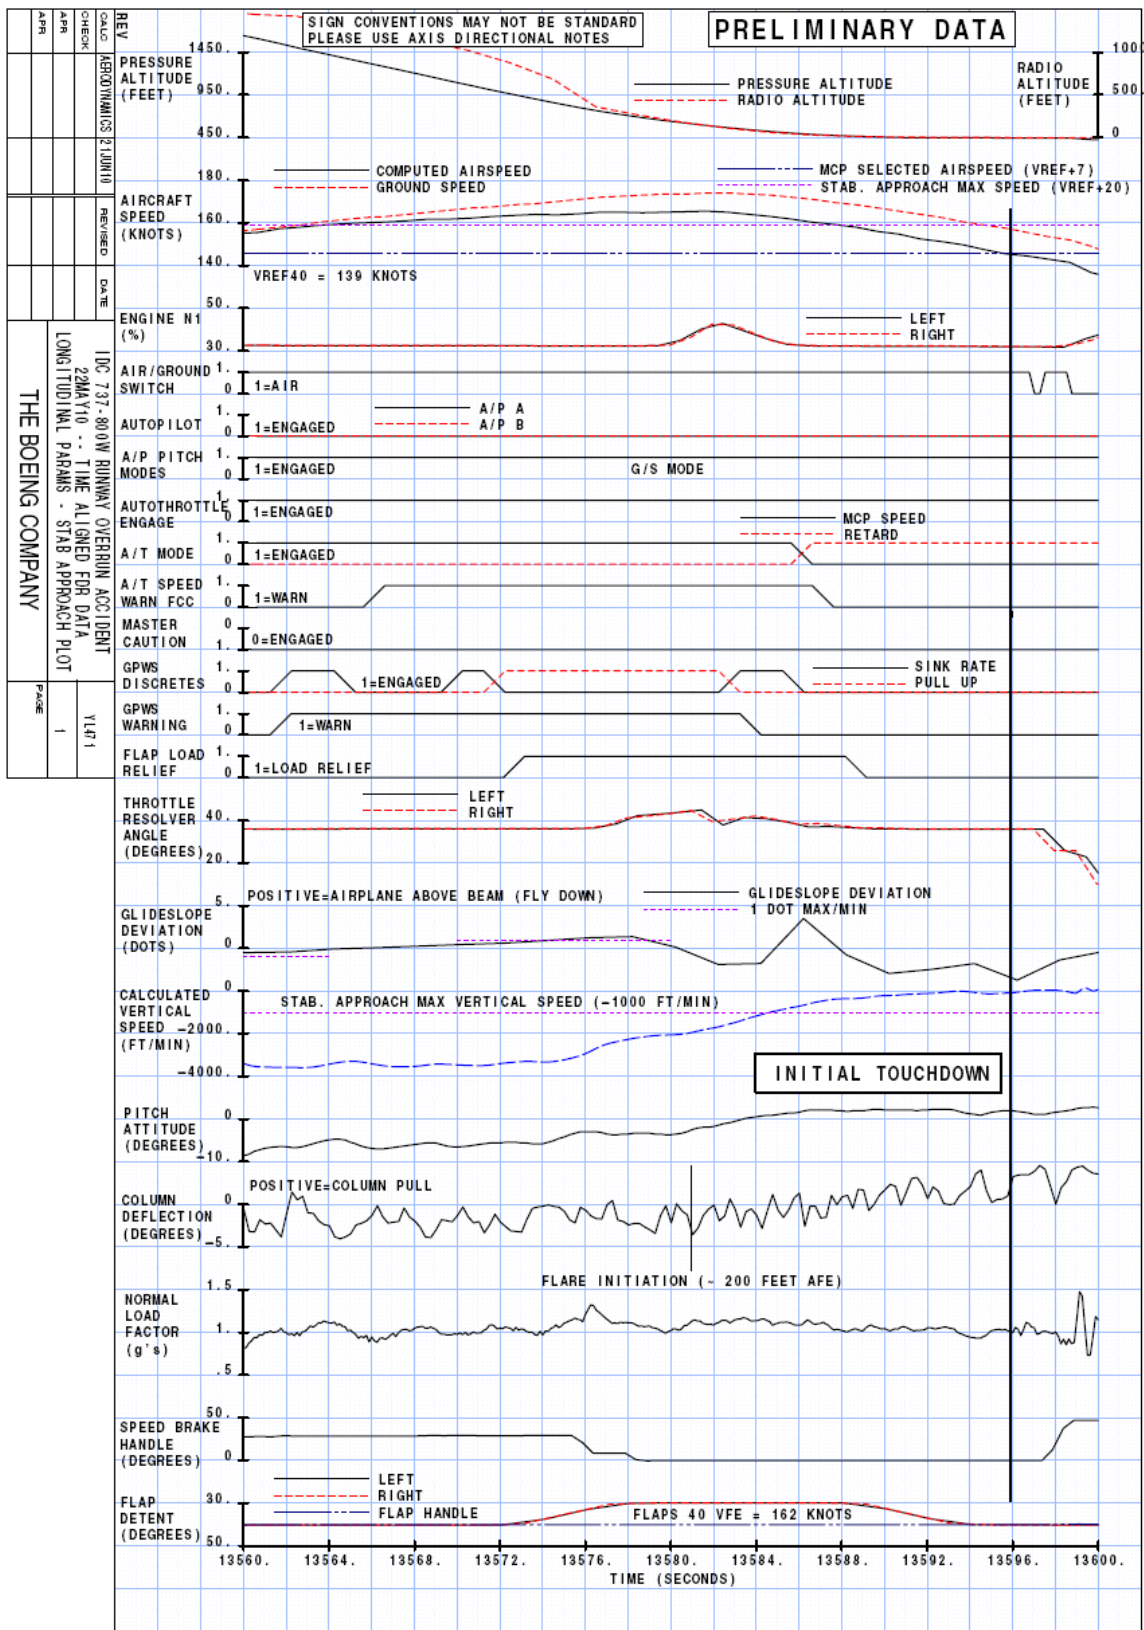
Figure: 1

The second criterion is "only small changes in heading and pitch are required to maintain the correct flight path." Figures 1 and 3 show a significant change in pitch during final approach. At 500 feet AFE, the pitch attitude was -6 degrees and increased to +2 degrees at touchdown. During a stabilized approach at Flaps 40, the nominal pitch attitude is -0.5 degrees at 500 feet AFE, per the 737NG Flight Crew Operations Manual (FCOM).

The fourth criterion is "the airplane is in the correct landing configuration." Correct landing configuration includes landing gear down, flaps extended and speed brakes stowed. Figures 1 and 3 show Speed brakes extended in the air at and below 500 feet.

The fifth criterion is "the airplane's sink rate is no greater than 1000 fpm (feet per minute)." Figures 1 and 3 show the airplane's sink rate (labelled 'Calculated Vertical Speed (ft/min)') was approximately 3300 fpm at 500 feet AFE and it remained above 1000 fpm until approximately 60 feet AFE. Numerous Ground Proximity Warning System (GPWS) discrete also annunciates during this time, "SINK RATE" and "PULL UP" warnings were recorded on both the Cockpit Voice Recorder (CVR) and the Flight Data Recorder (FDR).

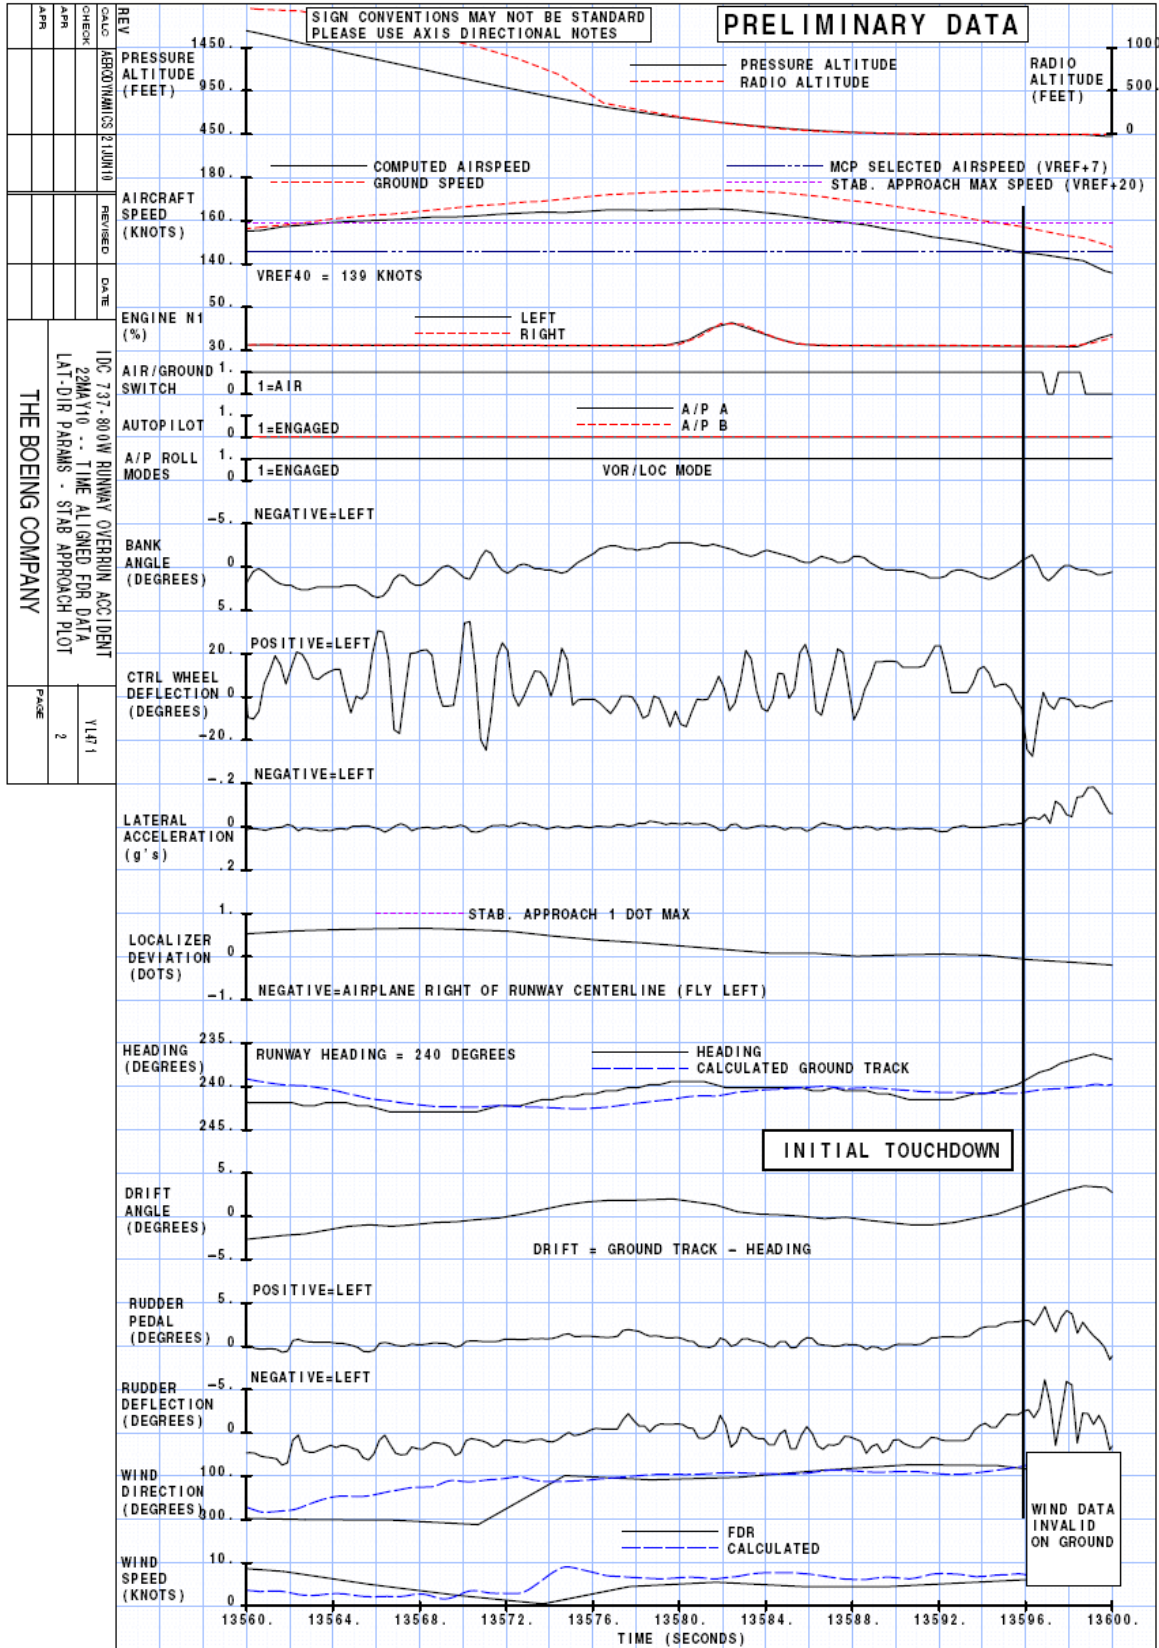
Figure: 2

The ILS approach criterion states "ILS and GLS approaches should be flown within one dot of the glide slope and localizer, or within the expanded localizer scale." Figure 2 shows the airplane was within one dot of the localizer all the way through the approach, but Figures 1 and 3 shows the airplane was not within one dot of a 3-degree glide slope.

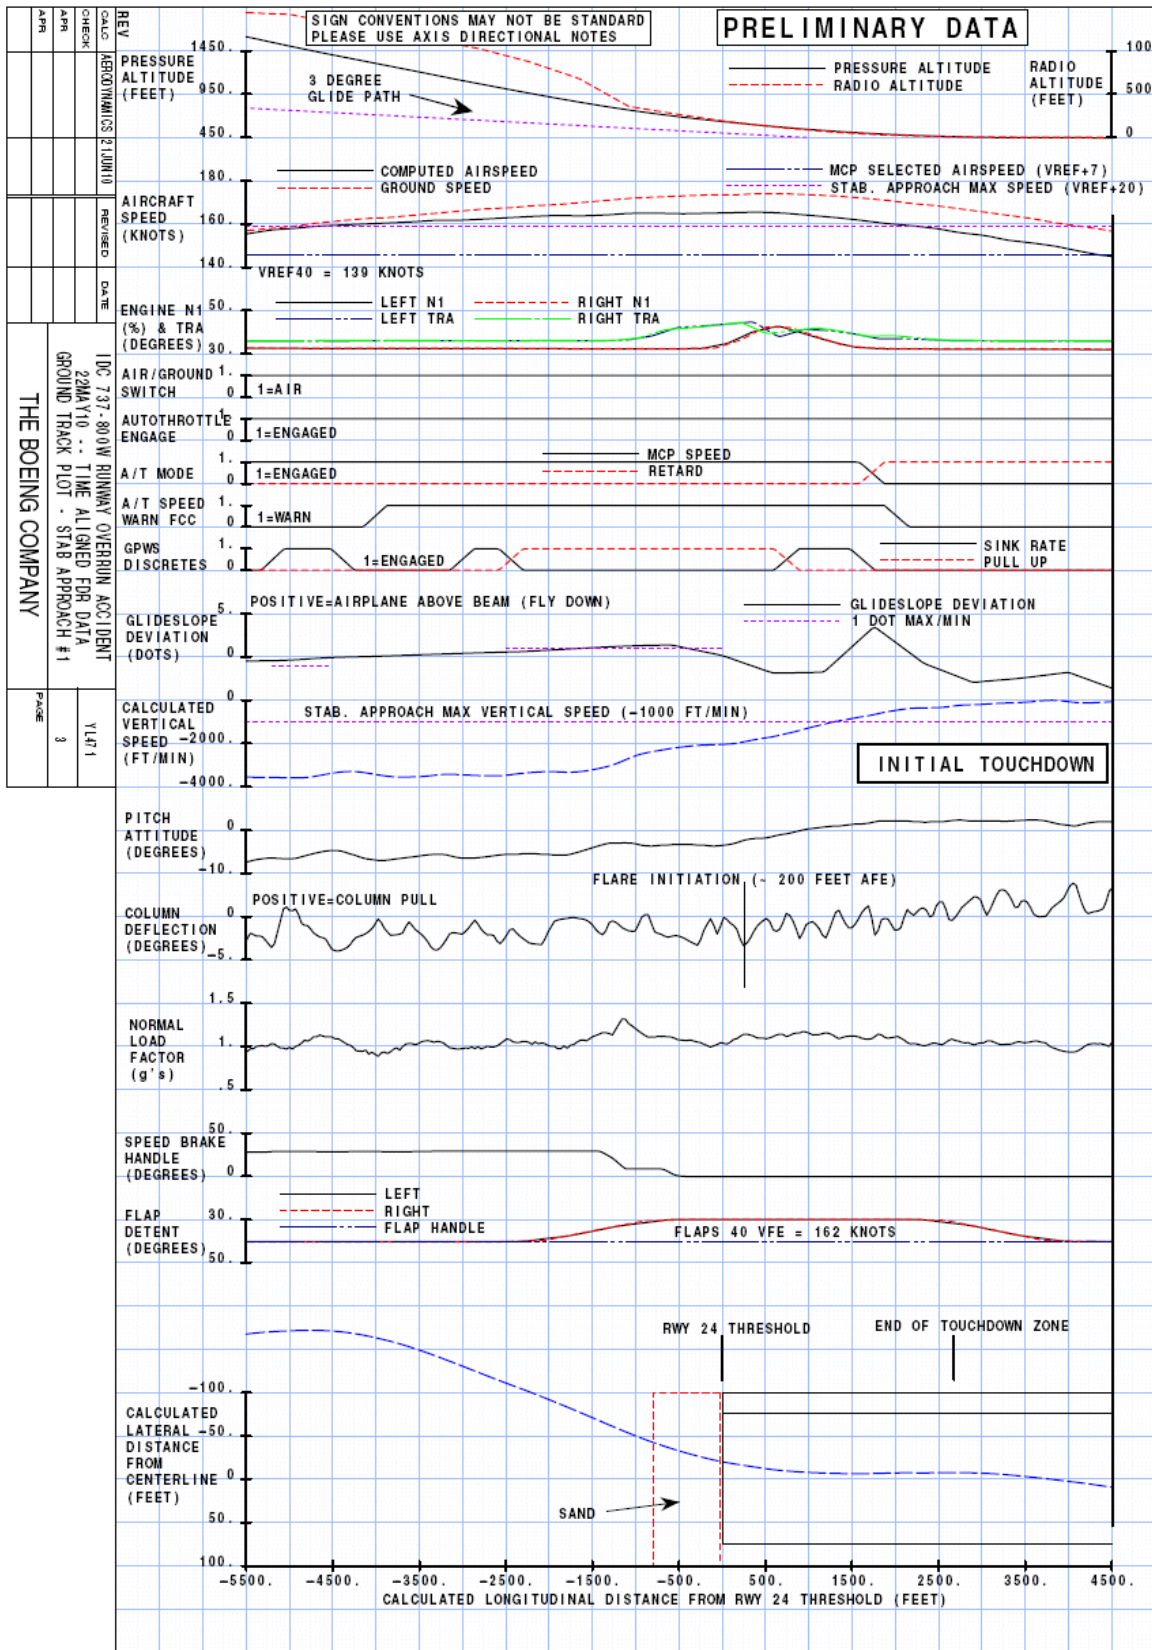
Figure: 3

The first criterion is "the airplane is on the correct flight path." As can be seen in Figure 3, the airplane was never on a 3 degree flight path during final approach. In order to be on a 3 degree flight path, the airplane should have crossed the final approach fix (FAF) at 2200 feet geometric altitude (airplane's true altitude above mean sea level (MSL)) but instead crossed at approximately 4475 feet, as can be seen in Figure 6.

The third runway-threshold-crossing criterion reads "as the airplane crosses the runway threshold, it should be . . . positioned to make a normal landing in the touchdown zone (the first 3000 feet or first third of the runway, whichever is less)." The airplane did not touch down within the touchdown zone. For Runway 24, the touchdown zone is the first third of the runway (~ 2679 feet). The airplane initially touched down approximately 4500 feet from the Runway 24 threshold (Figures 3 and 5). Thus, the touchdown point was approximately 1800 feet beyond the touchdown zone.

The airplane initially touched down approximately 4500 feet from the Runway 24 threshold. See Figures 3, 5 and/or 7.

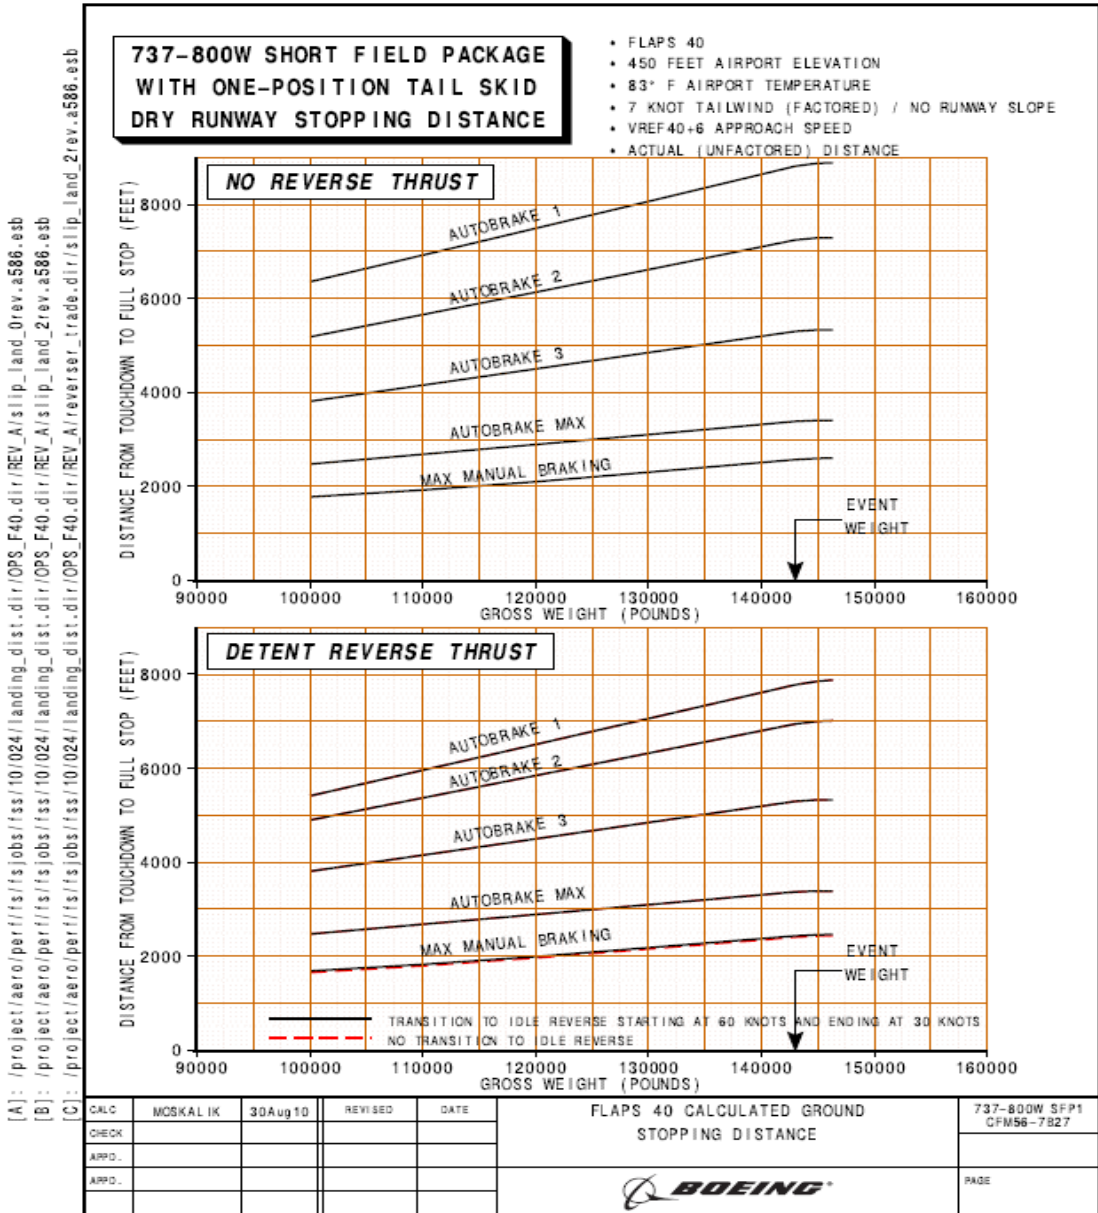
Figure: 8

The airplane does have adequate stopping performance to come to a complete stop on the improved surface available using a dry runway assumption. Based on the data from Figure 8 (described in the next paragraph) and the event airplane's weight (~143,000 pounds), the airplane could stop in approximately 2400 feet with the following assumptions: max manual braking, detent reverse thrust, Speedbrakes deployed, and reverse thrust maintained until fully stopped. Since the airplane's final touchdown point was approximately 5200 feet from the Runway 24 threshold, the airplane could have come to a complete stop at 7600 feet from the threshold (438 feet of runway remaining).

Figure 8 includes two plots showing airplane stopping capability. The upper plot assumes no reverse thrust, and the lower plot assumes detent reverse thrust. On both the upper and lower plots there are lines for auto brake settings of 1, 2, 3, and max along with maximum manual braking. The vertical scale shows the distance from touchdown to a complete stop. Transition from touchdown to full braking assumes: brake initiation (auto brakes) at touchdown (manual braking is one second after touchdown), speed-brake select one second after touchdown, and reverse thrust (if applicable) select one second after spoiler select. No flare distance is included.

The conditions are labelled in Figure 8 and are meant to reflect the actual conditions of the event: Flaps 40, 450 feet pressure altitude, 83° F outside air temperature, touchdown speed of VREF40+6 knots and a reported 7 knot tail wind. The wind value was conservatively factored by 1.5, so that the calculation assumed a 10.5 knot tailwind. This is consistent with the Airplane Flight Manual and FCOM calculation method. In addition, all airplane parameters used in the calculation are consistent with the databases used to develop the airplane flight manual and operational performance data provided in the FCOM.
